Infrastructure Damage Assessment

Cabo Delgado – Mozambique

August 2022

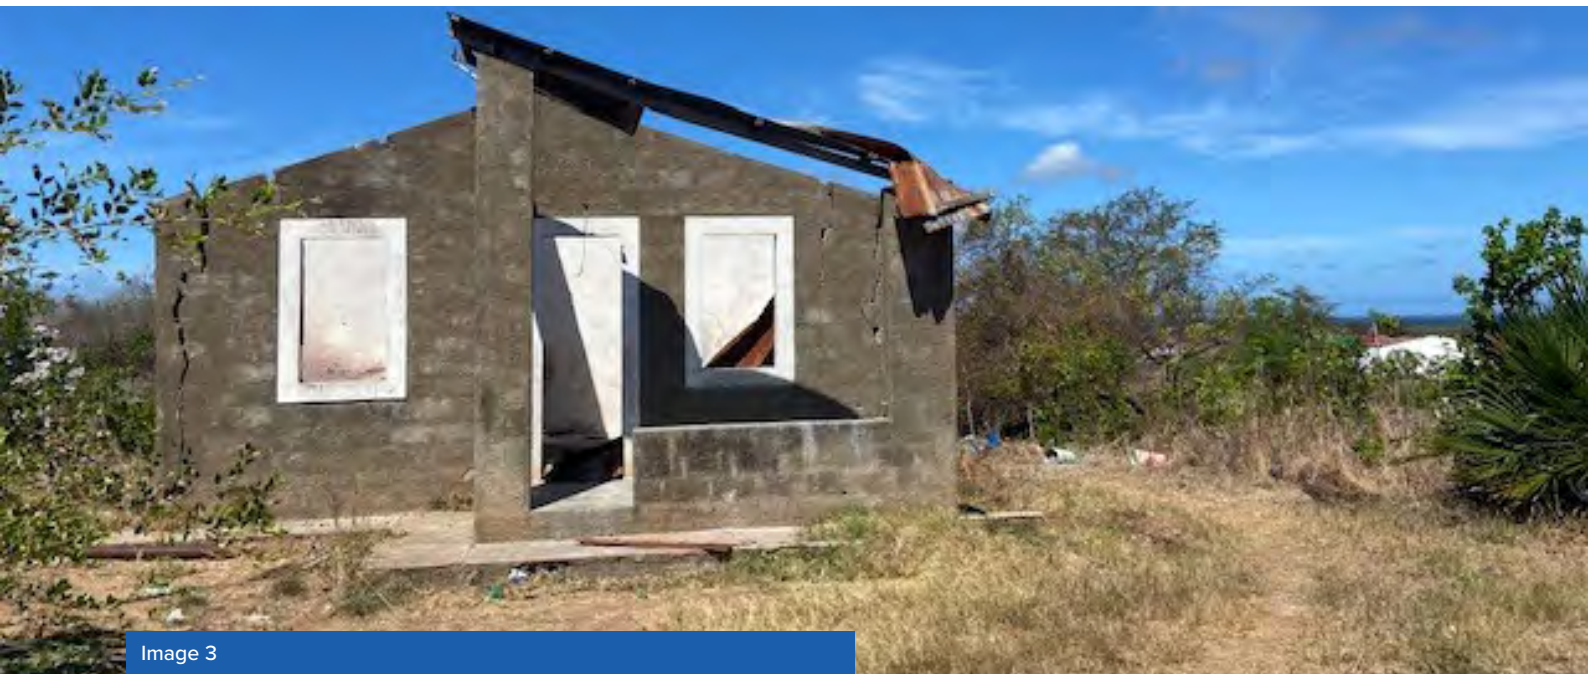
Image 3
The housing unit of a civil servant in Quissanga sede (Quissanga district).

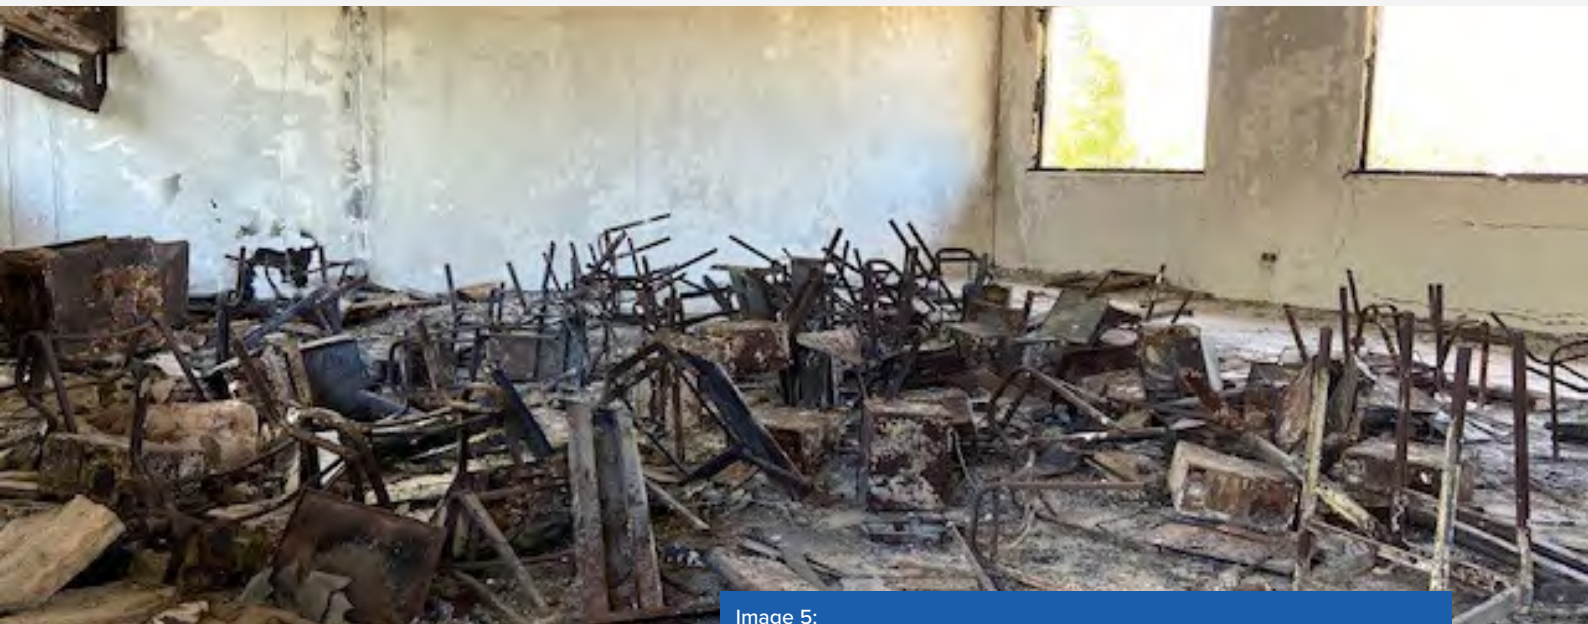
Image 5: Computer classroom completely destroyed in Bilibiza (Quissanga district).

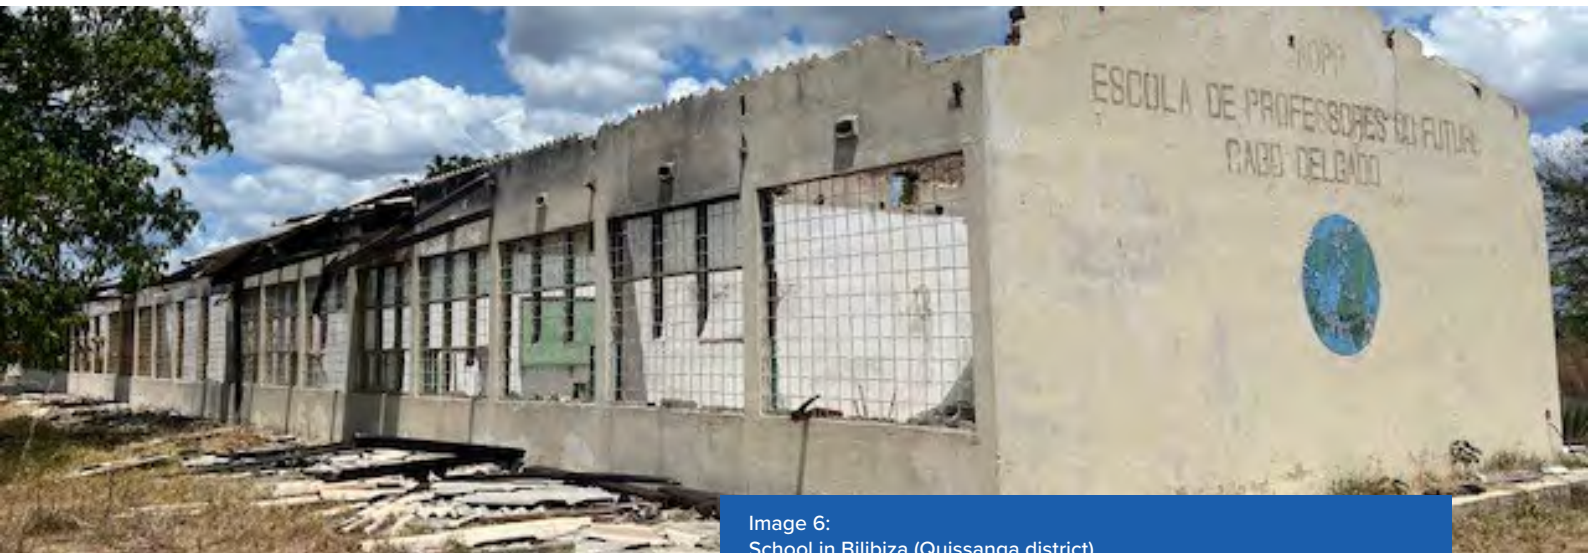
Image 6:
School in Bilibiza (Quissanga district).

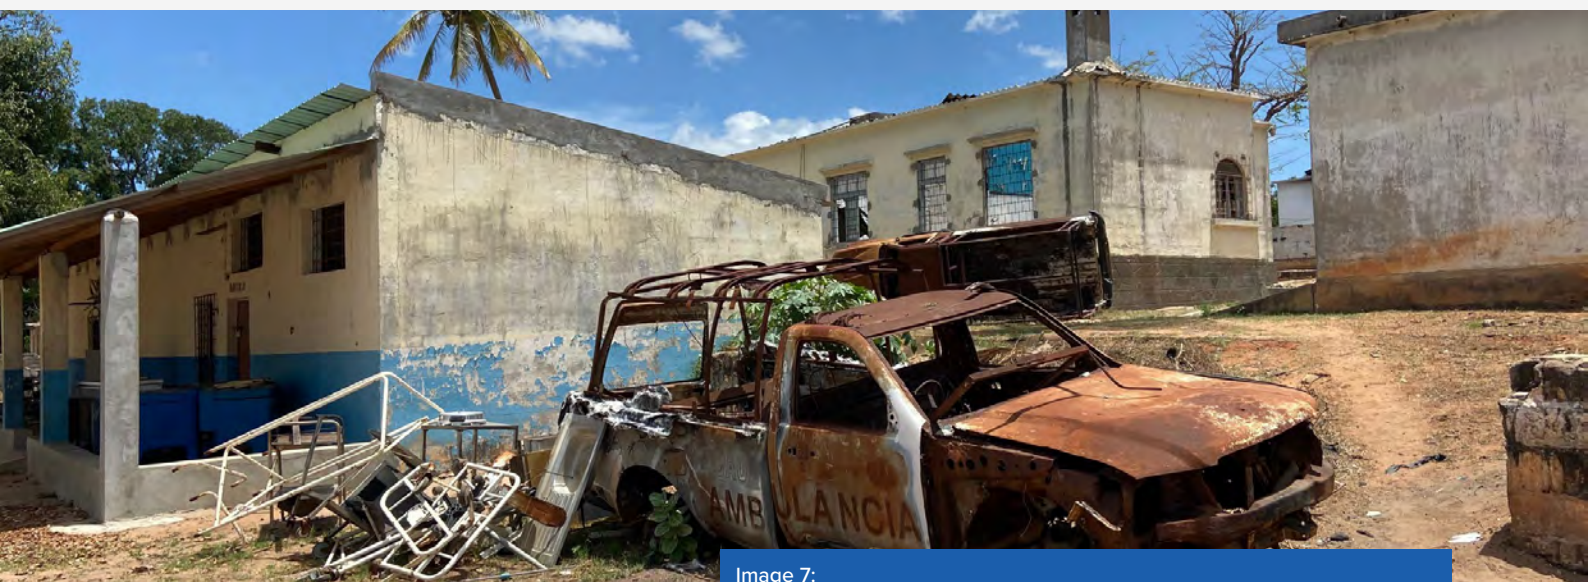
Image 7: Hospital in Macomia sede (Macomia district).

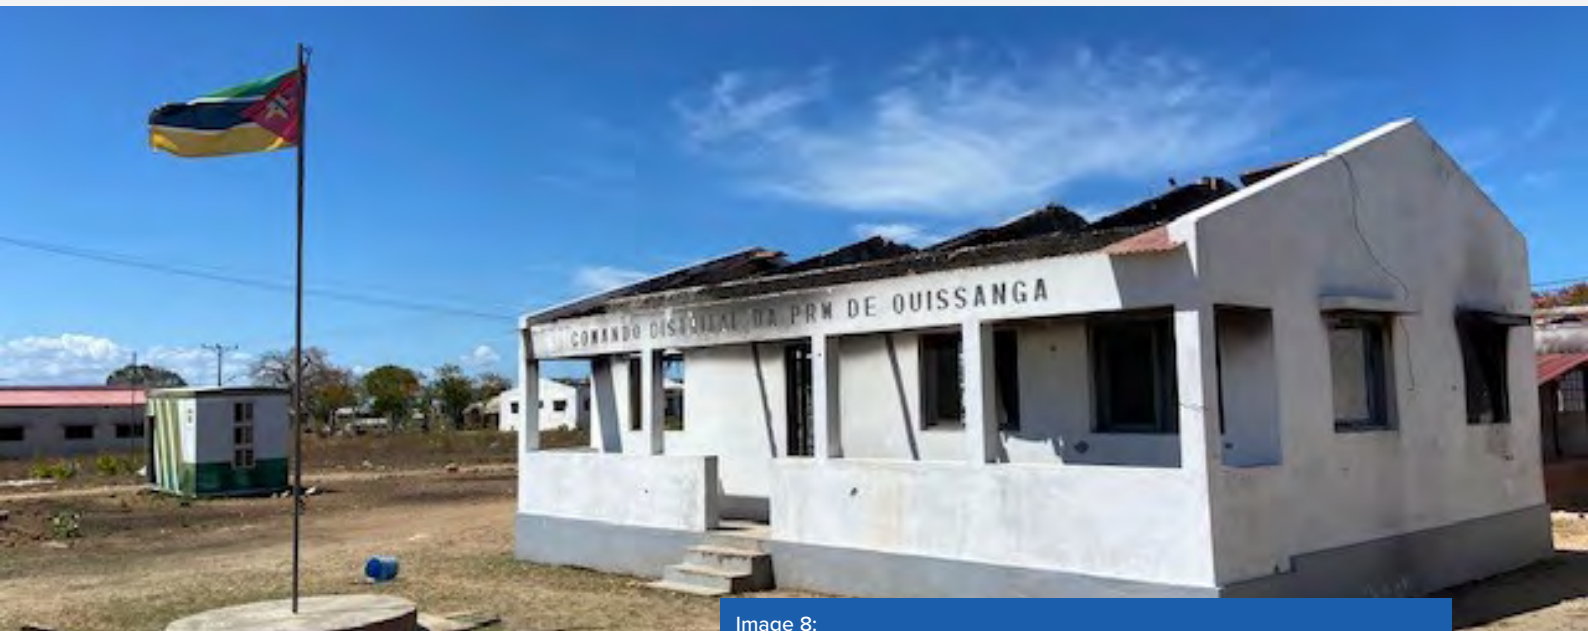
Image 8: Police station in Quissanga sede (Quissanga district).

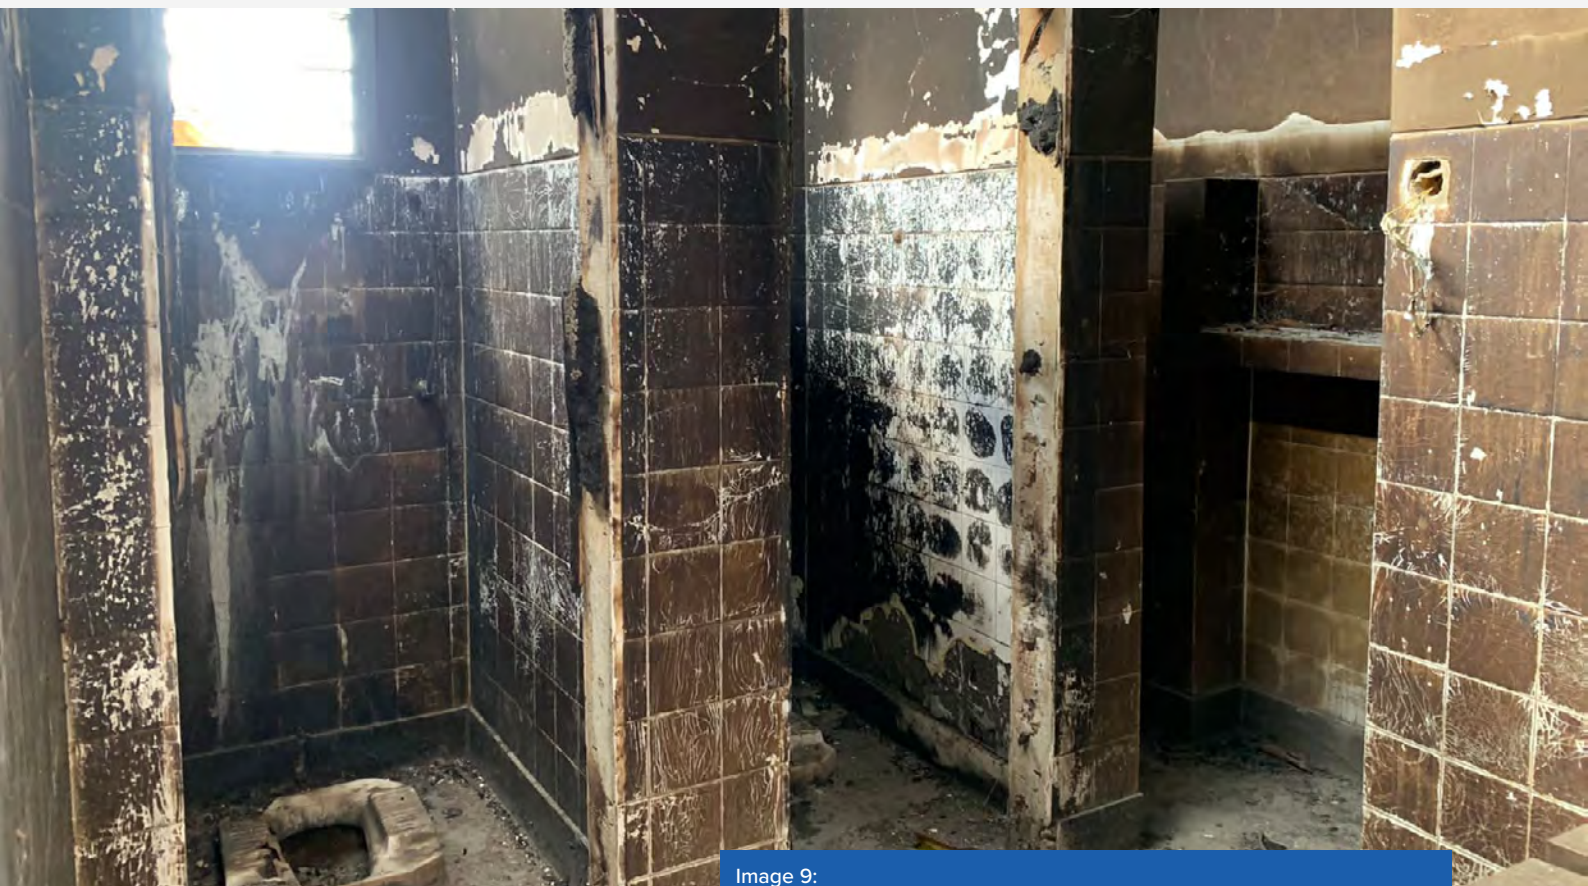
Image 9:
Hospital toilet in Macomia sede (Macomia district).
