# The Armenian Church and Monastery Restoration Project

# The Armenian Church and Monastery project

# Restoration

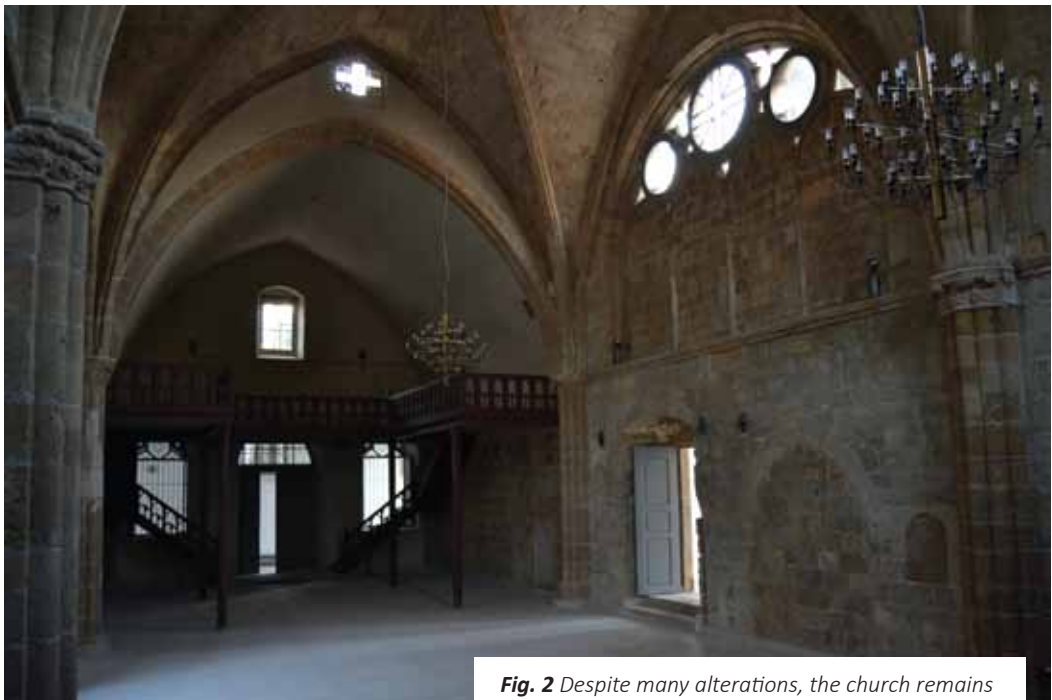
**Fig. 2** *Despite many alterations, the church remains an outstanding example of Cypriot gothic architecture. In the walls in the foreground of this photo one can see the outlines of the original fourteenth-century niches, which were filled in during the renovations in the early sixteenth century. The barrel vault in the background and the door on the north wall were added at the same time. (Vitti)*

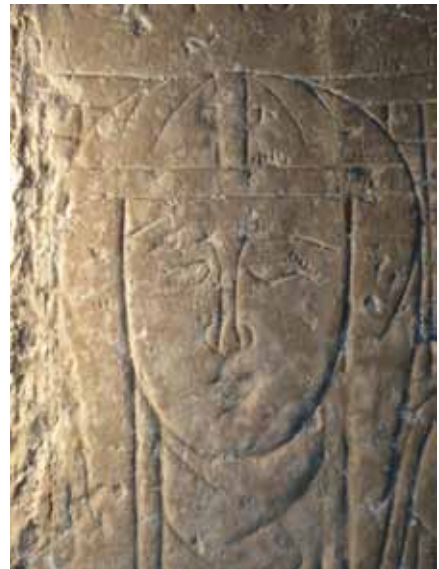
**Fig. 4** A rare example of Cypriot gothic funerary art, the carved relief of the Abbess Eschive de Dampierre was originally shaped to fit into a niche inside the church. (Vitti)

A cornice divided the windows from the lower wall which was punctuated by niches, one of which can be identified as the original location of the tomb of Abbess Eschive de Dampierre (d. 1340), now located on the northern porch. This tomb is one of the few surviving masterpieces of Cypriot gothic funerary art. The carved relief of the Abbess and her coat of arms is crowned with a gabled cornice and was originally shaped to fit into one of the wall niches.

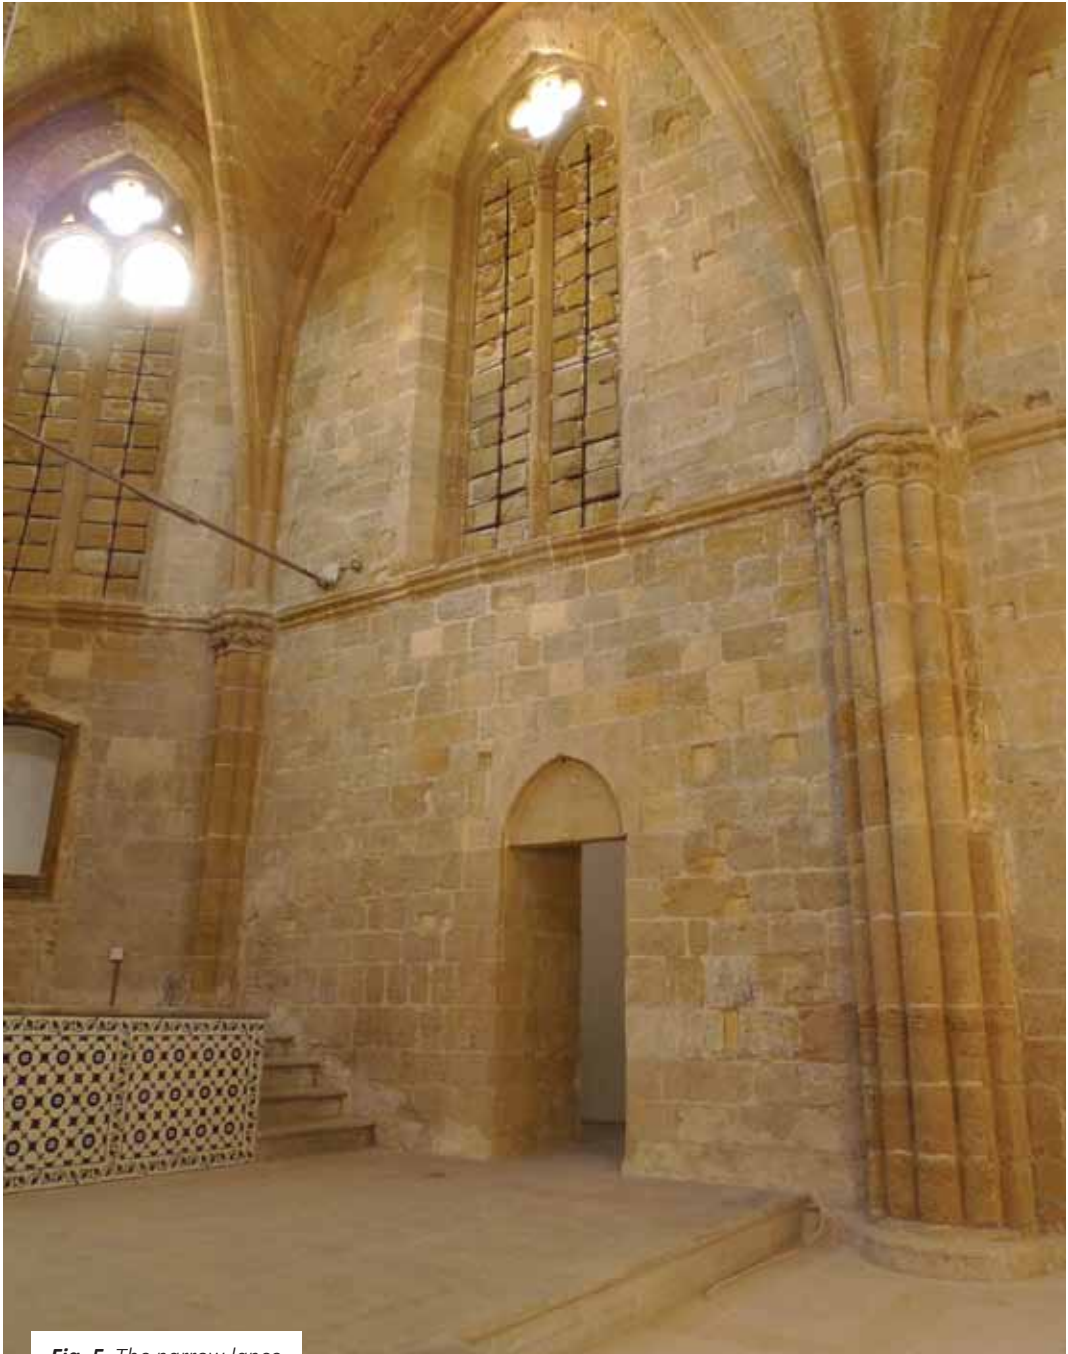
**Fig. 5** The narrow lance shape of these windows and the decorative, four-leafed quatrefoil tracery are classic features of gothic ecclesiastical architecture. (Vitti)

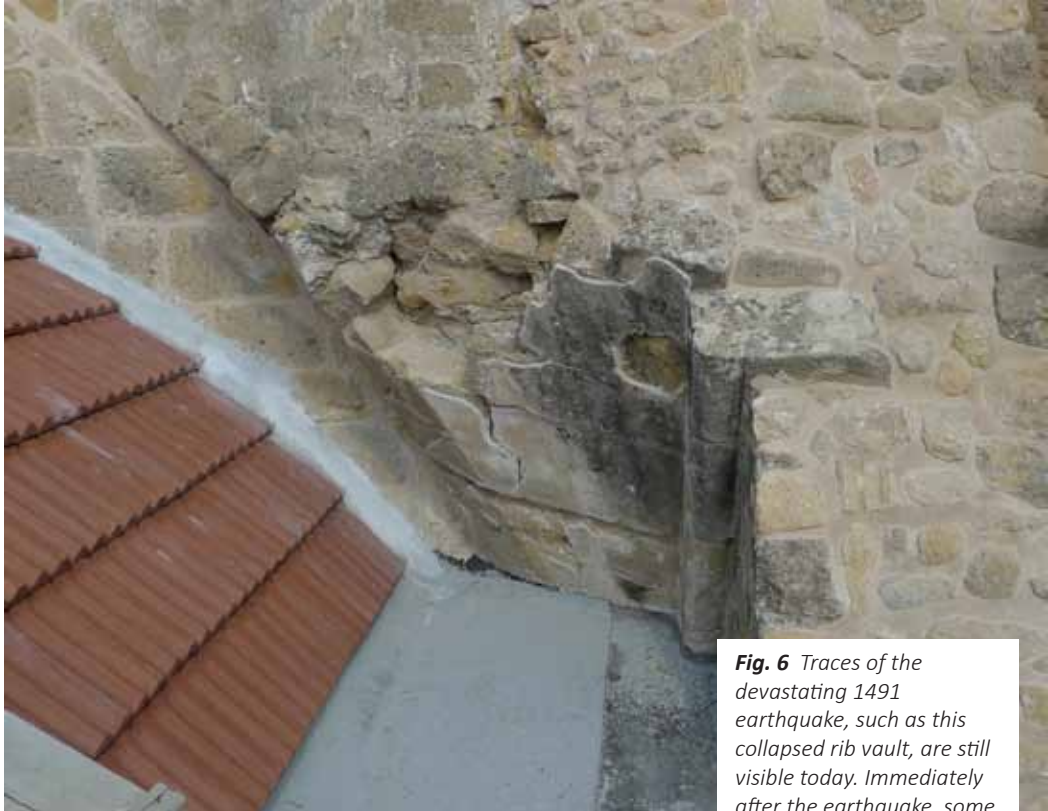
In the 1491 earthquake the first bay's ribbed vault and the entire western facade collapsed. Traces of this devastating event, such as the ruined northern wall and part of the collapsed ribbed vault, are still visible today, despite many subsequent renovations. The initial repairs included a wall separating the ruined first bay from the rest of the church and a new access door on the south wall. The church continued to be used in this semi-derelict state for some time.

**Fig. 6** *Traces of the devastating 1491 earthquake, such as this collapsed rib vault, are still visible today. Immediately after the earthquake, some parts of the church were walled off or only partially repaired. The once wealthy Benedictine monastery may have been losing influence by the end of the fifteenth century. (Vitti)*

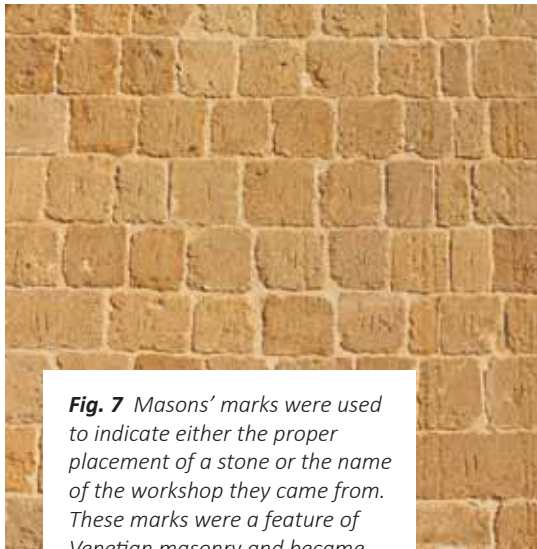
**Fig. 7** *Masons' marks were used to indicate either the proper placement of a stone or the name of the workshop they came from. These marks were a feature of Venetian masonry and became common in Cyprus in the sixteenth century along with many Venetian architectural motifs. (UNDP-ACT)*

Stylistically, the modifications described in the previous paragraph exhibit the strong Venetian influence present in sixteenth-century Cypriot architecture. Many Venetian architectural features, such as drop arches, profile mouldings and masons' marks, were used in Cypriot architecture during this period and the reconstructed first bay and the new porch clearly show this new architectural language.

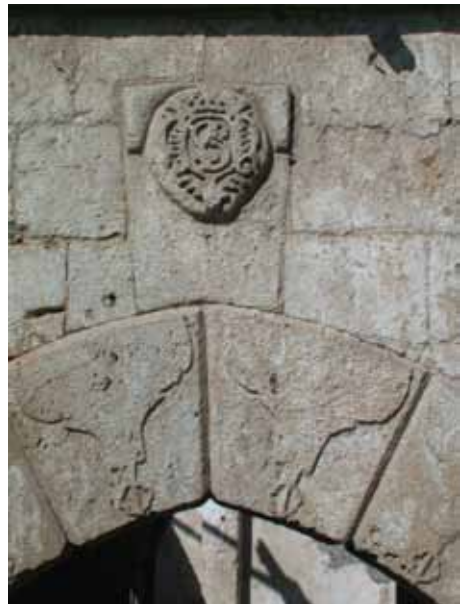
**Fig. 8** *This carved stone gate marked the entrance to the beautiful and well-fortified Melikian mansion. By the sixteenth century much of the original Benedictine monastery had been dismantled and the stones were used in new buildings. (BCD Progetti)*

By the time of these renovations, the ancillary buildings of the monastery had been dismantled and the remains of these buildings were used in the construction of new houses. The Melikian Mansion, a house to the east of the church, was built by a wealthy merchant around the sixteenth century. It is distinguished by a well-protected storage/treasure room on the ground floor, an arched loggia on the first floor and a nicely carved arched stone gate on the same side as the loggia.

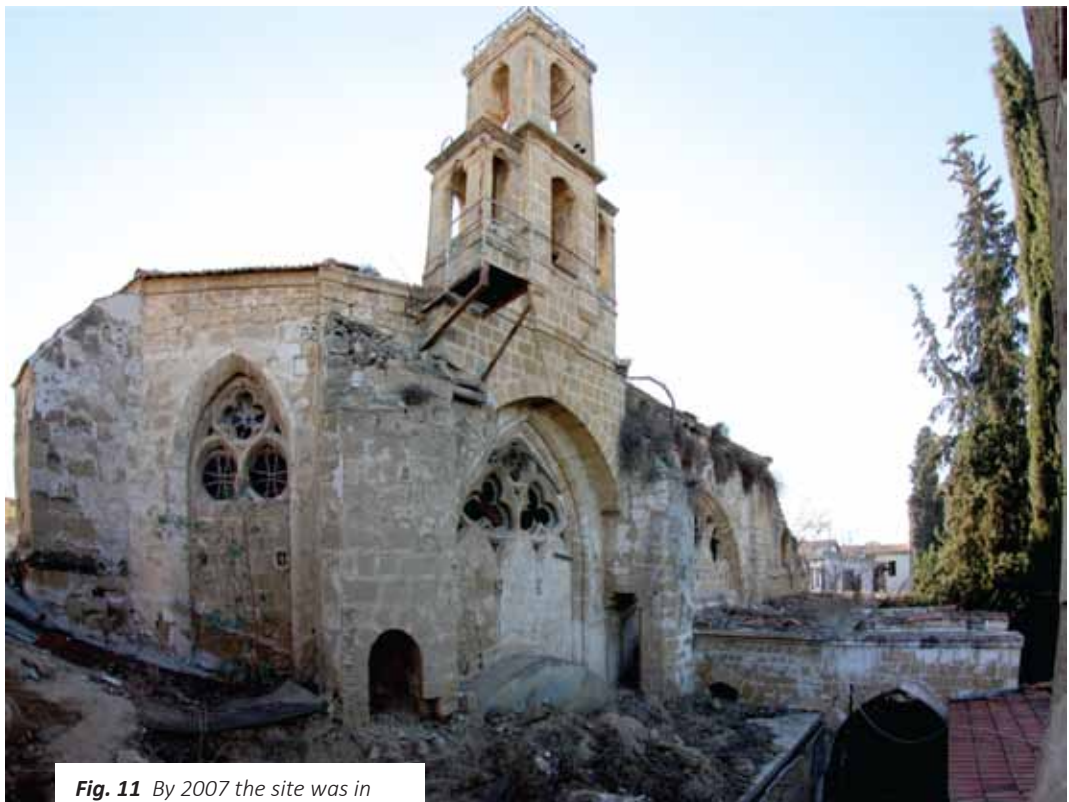
**Fig. 11** *By 2007 the site was in urgent need of attention. As a first step, the historical and cultural importance of each building was assessed, as well as its state of repair. (BCD Progetti)*

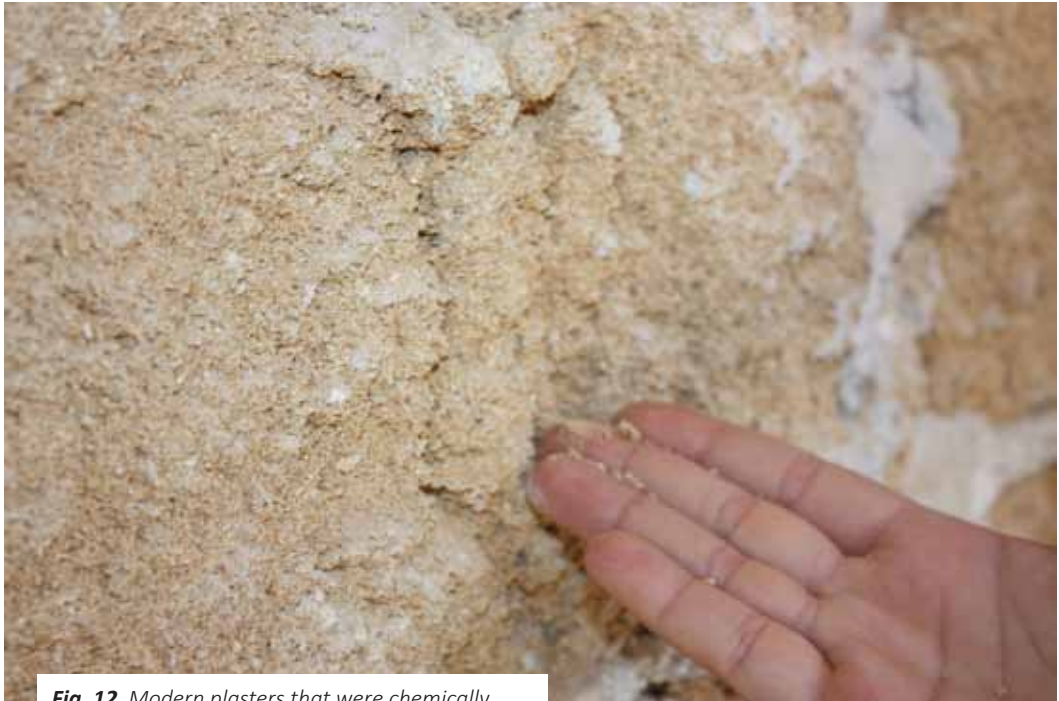
When the design phase began in 2007, large portions of the site were in need of immediate intervention, while others had already collapsed. The church, with the possible exception of the northern porch, had not suffered serious structural damage. However, broken and missing windows and a leaking roof, combined with the humid climate, had created the circumstances for heavy material damage. In addition, the gypsum and cement plasters used in previous renovations and repairs had damaged both the interior and exterior walls. Some of the soft sandstone blocks were crumbling and intervention was needed to prevent further deterioration.

**Fig. 12** Modern plasters that were chemically incompatible with the sandstone, cement mortar repairs and the humid climate of Nicosia together reduced some blocks to dust. (BCD Progetti)

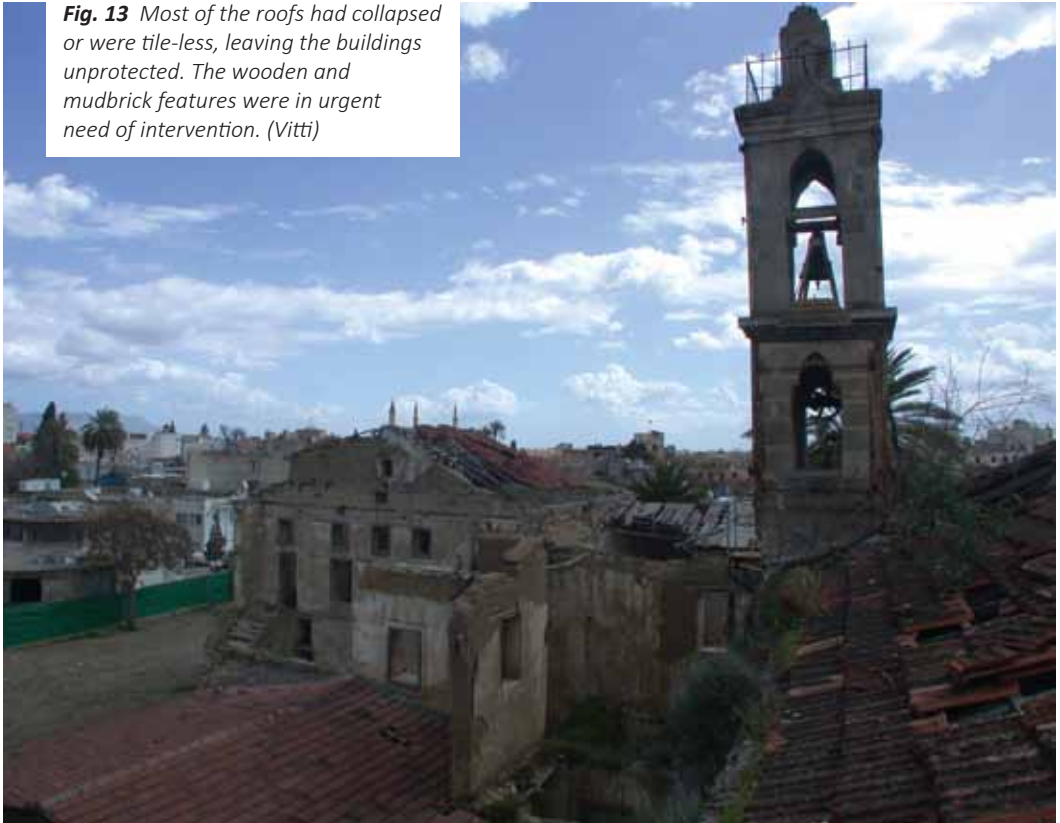
Melikian's Mansion (Building B in the foldout site plan, page 30) suffered the most severe damage. Most of the roof had collapsed or was tile-less, leaving the rooms unprotected. The woodwork in the traditional Cypriot false ceiling had suffered serious damage and rain had heavily eroded the mudbrick masonry. The overall structural condition was critical, especially the loggia on the eastern side of the mansion, which was near collapse. The other buildings, including the schools and the premises of the Prelacy, needed to be secured against future deterioration.

**Fig. 13** Most of the roofs had collapsed or were tile-less, leaving the buildings unprotected. The wooden and mudbrick features were in urgent need of intervention. (Vitti)

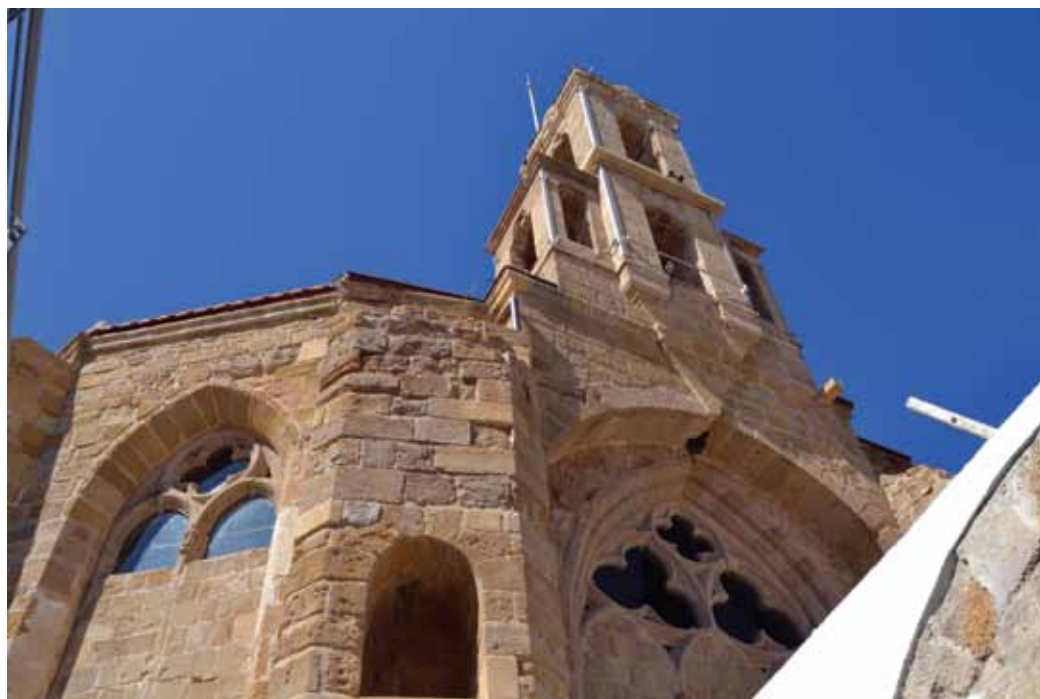
**Fig. 15** *The belfry and the buttresses were the last major additions to the church. (Vitti)*

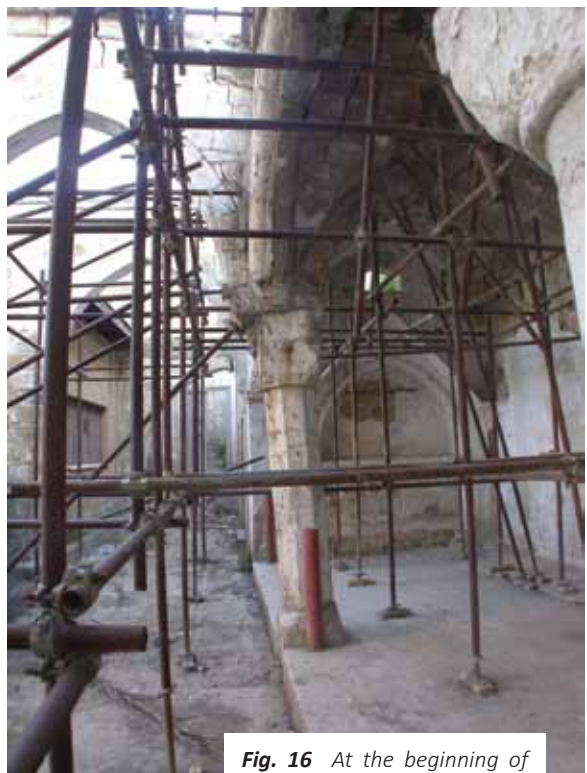
Structural decay had seriously damaged the porch, which was near to collapse. The pillars had been gradually overturned by the thrust coming from the heavy load of the vault and the roof above. This slow but steady pressure had distorted the overall geometry of the vault and some of the wedge-shaped stone voussoirs, which form part of the arches, had fallen or were about to fall. All the columns of the porch were visibly inclined outwards. Structural decay was also visible on the north side of the church. The most serious problems were deep cracks in the choir's ribbed vault.

**Fig. 16** At the beginning of the project, the porch was in imminent danger of collapse. Every one of the pillars was slanted, and the buttresses were cracking. (BCD Progetti)

Soil tests and georadar records established that the damage was not caused by the settlement of the foundation. A three-dimensional model of the church was used to simulate its behaviour under different types of stress and allowed the design team to determine that the cracks in the church vault had been caused by the nineteenth century addition of the heavy bell tower. They also established that the structure, after the initial damage, had stabilised; therefore, the cracks on the vault under the bell tower could be safely filled in without extra support being added.

The structural damage to the porch was caused by two factors: the heavy load on the vaults and the corrosion of the iron tie rods. In both cases, the design team chose an “intervention without alteration” strategy. The buttresses built in the nineteenth century to support the sixteenth century pillars were themselves widely cracked and tilting. Instead of adding new structures, or repairing the old repairs, the engineers chose the more effective, yet challenging, option of restoring the porch’s earlier configuration, load and tie rods efficiency. To do this they had to apply a force equal to the force that had caused the porch to collapse (mainly gravity), but in the opposite direction (i.e., upwards). In other words, they decided to literally push the porch back to its original position.

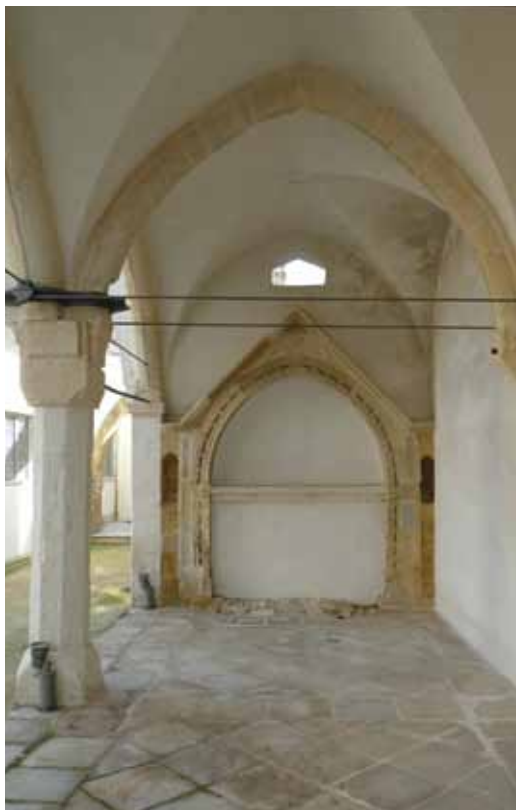
**Fig. 17** The engineers chose the more effective, yet challenging, option of restoring the porch’s earlier configuration. (UNDP-ACT)

The challenge was to re-establish the upward thrust in the reverse sequence to which the collapse had occurred. Once the vaults were repositioned they would help to push the arches back to their original position; once the drift of the arches was reduced, it would be possible to apply an external push to the columns and re-establish the original geometry of the whole addition. The force applied had to be strictly controlled to avoid crushing the fragile sandstone used for the porch structure.

In the next step, the joints between the stones in the vaults were cleaned to allow each separate element to be moved without creating new cracks. Three temporary steel buttresses were then erected around the porch. Each exerted 20 tons of force on the arches via their hydraulic jacks. Once all of these preparatory steps were completed, the porch could be moved in carefully calculated and controlled steps, a few centimetres at a time. At each step, the geometrical layout was fixed, and the tension was transferred to the new stainless steel tie rods. After many cycles, the initial goal was reached and the porch was fully restored, without having to substitute a single stone. The final stage involved backfilling the masonry joints and restoring the ancient drainage along the top of the buttresses.

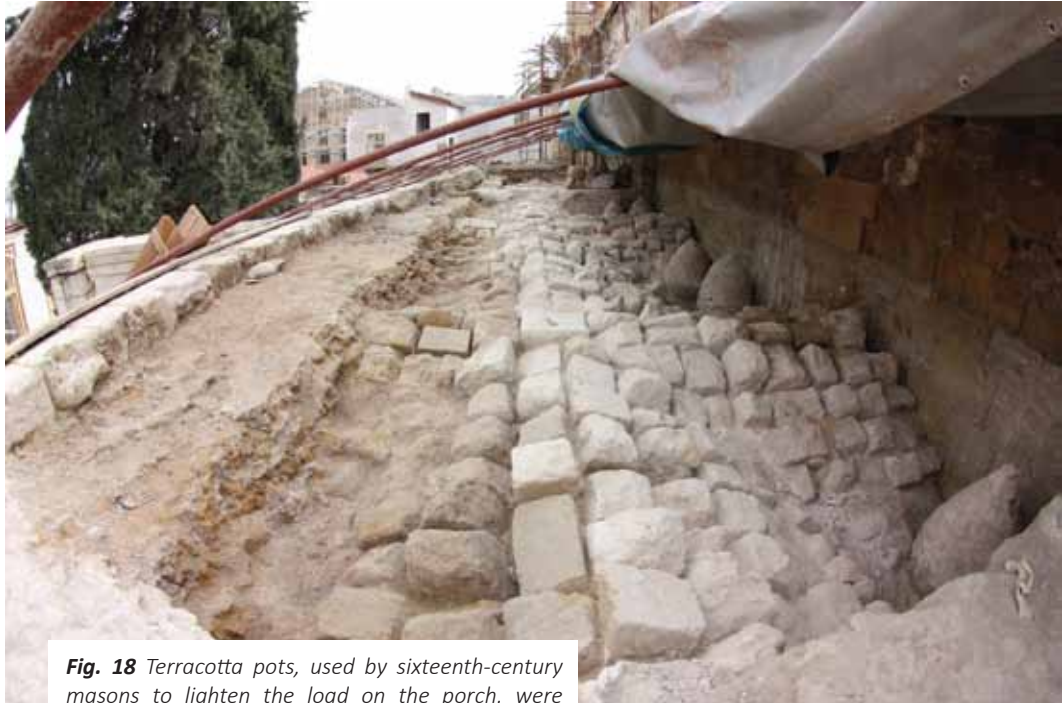
**Fig. 18** *Terracotta pots, used by sixteenth-century masons to lighten the load on the porch, were discovered when the heavy terrace floor, seen on the left of the photo, was removed. (BCD Progetti)*

The first step in this process was to shore up the vault; the next step was to decrease the substantial weight of overlying fill, to prevent the porch from slowly collapsing again. Like every other part of this project, this led to unexpected discoveries. When the team dismantled the floor of the terrace, which formed the roof of the porch, they uncovered a series of terracotta pots, which had been used by the original builders in an attempt to lighten the weight on the supporting structure. These pots have been protected and left in their original location.

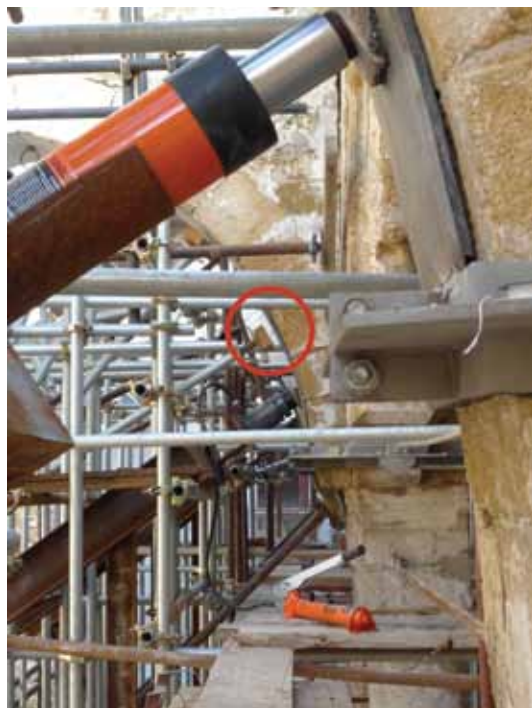
**Fig. 19** The project engineers invented a technique using hydraulic jacks to literally push the collapsing sixteenth-century porch upright, one centimetre at a time. The circle in the picture shows the gap between the original prop, and the location of the arch after it has been slowly pushed back into place. (BCD Progetti)

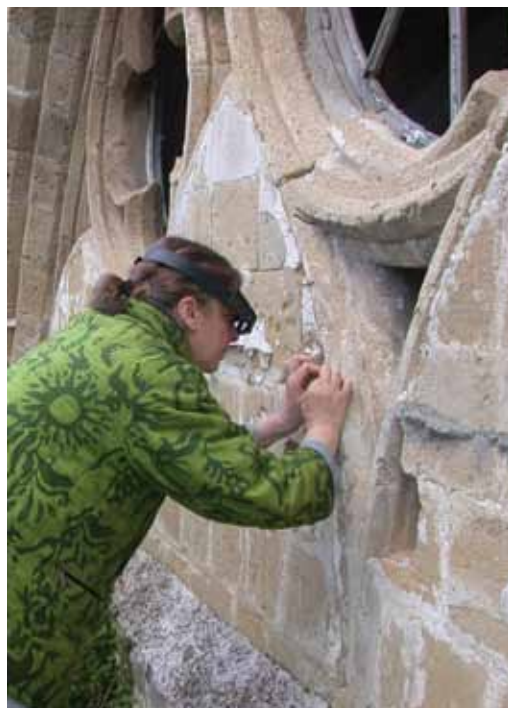
**Fig. 20** A conservator from the Istituto Centrale del Restauro tests the original plasters during the Assessment of the Church. One of the most technically challenging tasks was to remove the modern plaster that was damaging the underlying stone, without damaging the traces of older plaster beneath it. (Vitti)

During the design phase, conservators tested several methods for removing the modern plasters from the interior surfaces of the church. These trials were essential to ensure that the adherent cement plasters could be removed without further damaging the decayed stone. The conservators also needed to detect and preserve the rare and extremely thin fragments of the original fourteenth-century lime plaster.

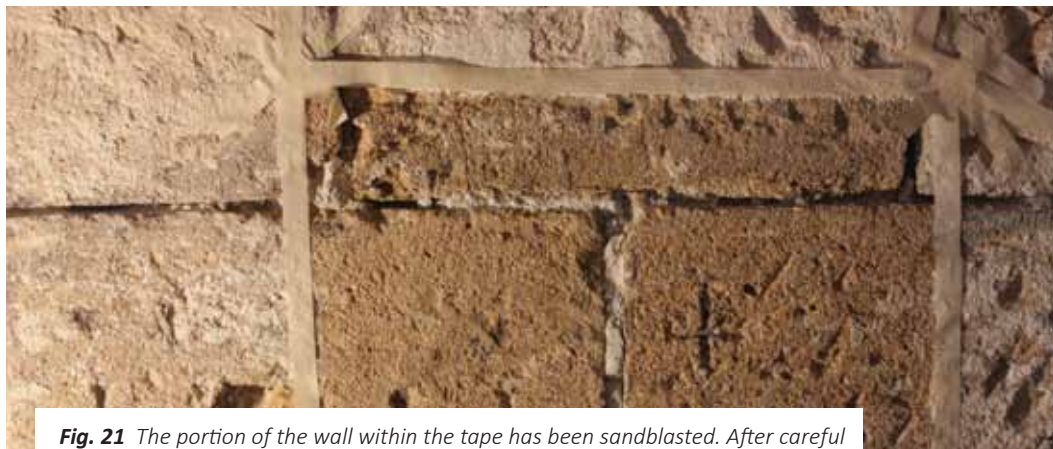
As the project progressed it became clear that over the years the addition and removal of plaster and other materials, and the humid conditions, had so damaged the original stonework that some degree of stone restoration and even replacement was necessary. The most damaged stones were found on the southern exterior surface and the interior vaults. Different intervention strategies had to be devised for these two areas.

**Fig. 21** The portion of the wall within the tape has been sandblasted. After careful testing, this technique was used to remove the last thin layer of modern mortar that could not otherwise be removed without harming the stone. (BCD Progetti)

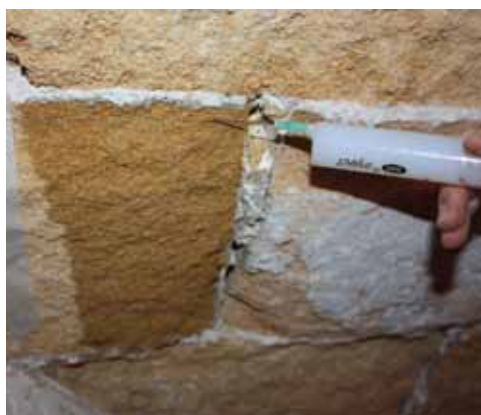
**Fig. 22** Conservators injected liquid consolidants into the pulverised stones, to strengthen the decayed stone. This allowed the project to preserve many of the damaged original stones. (BCD Progetti)

Stones with minor damage were consolidated and preserved; only stones that were disintegrating into fragments and dust, and thereby threatening the stability of the masonry were replaced. This respect for the authenticity of the fabric required a careful stone by stone examination before any decision regarding consolidation or substitution was approved. This minimum intervention strategy was applied to all surfaces, but the substitution of the stones on the exterior surfaces was more extensive, due to climatic factors, which both increased the weathering of the stone and reduced the penetration of the consolidating material.

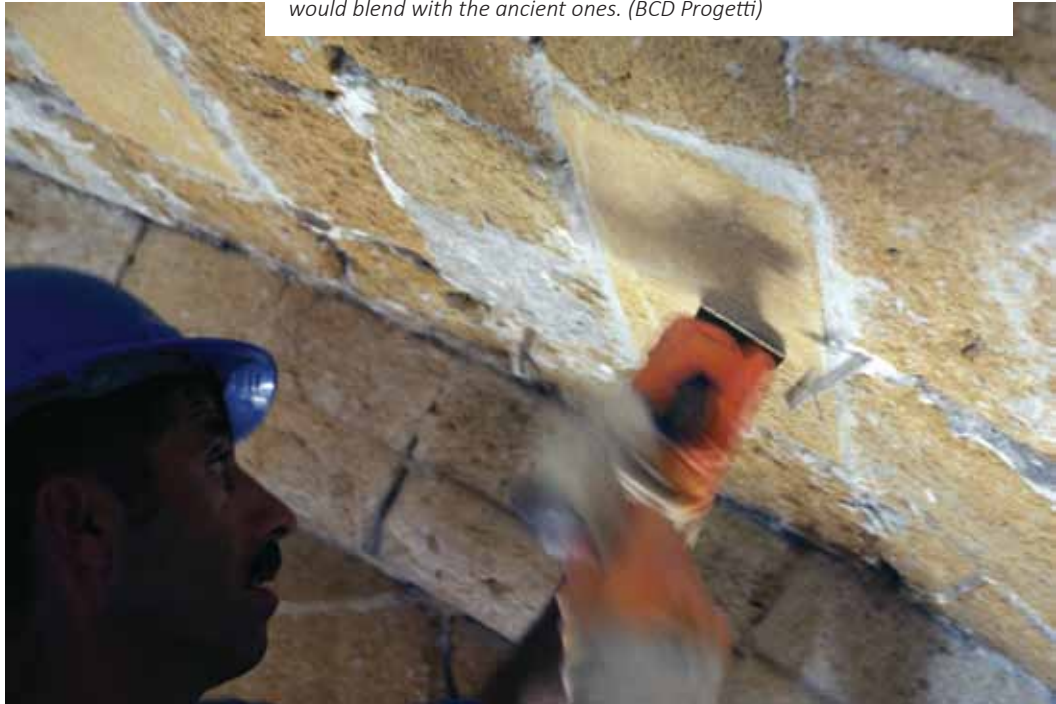
**Fig. 23** *Masons used coarse-tooth chisels to mimic the effects of historical stone-cutting techniques and weathering so that the new stone blocks would blend with the ancient ones. (BCD Progetti)*

The final and most delicate phase of the intervention was the aesthetic presentation of the newly cleaned and conserved walls. First, to match the new stones to the existing stone surface, the new stones were roughened along the edges with a chisel wherever the neighbouring stones were visibly decayed. For similar aesthetic reasons the new stone surfaces were treated with a coarse-toothed bush hammer, making them look more like the ancient ones.

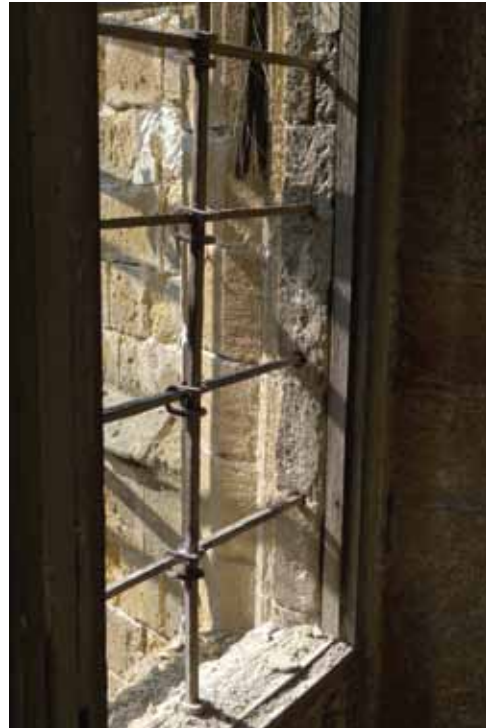
**Fig. 24** *These metal gratings supported a stained-glass window in the original fourteenth-century church. (Vitti)*

Each stage of restoration revealed a wealth of new information about the site. Two unexpected discoveries were the gratings used in the original gothic windows and two painted bosses on the key of the vault. The former, exceptionally important for Cypriot gothic architecture, were the original metal gratings that supported the gothic stained glass. These gratings had been visible before the intervention, but had been interpreted as modern gratings. The removal of the gypsum plasters used to wall up the windows revealed that these gratings ran the height of the window and belonged to the original fourteenth-century church. These are, to our knowledge, the only known examples of stained glass window supporting structures in Cyprus. The metal was treated to preserve it for years to come.

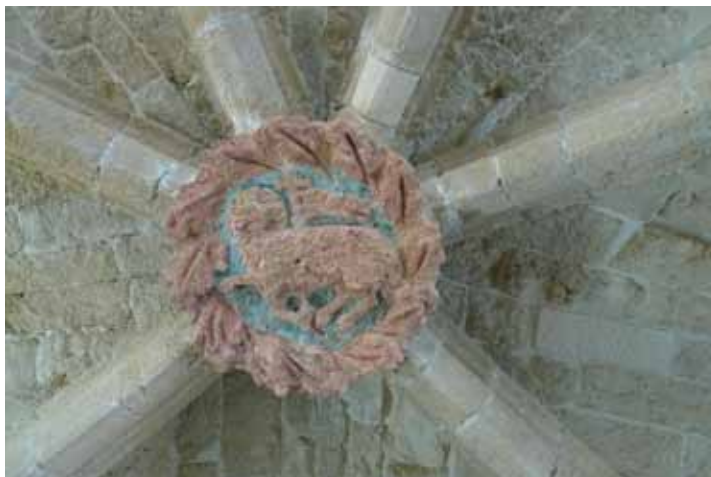
**Fig. 25** *The removal of thick layers of gypsum plaster from the bosses, on the ceiling revealed two intricately carved surfaces. The most elaborate design was an agnus dei. This 'Lamb of God' is a common Christian symbol. (Vitti)*

The second discovery was two decorated bosses. After removing the thick gypsum layer from the key stones at the intersection of the vaults' ribs, two delicately carved surfaces came to light. The boss at the intersection of the second bay is a simple pattern with leaves that circle the central area, while the boss above the choir is an impressive agnus dei. This "Lamb of God" is represented in the traditional form of a lamb looking backwards, holding in its right foreleg a Christian banner with a cross.

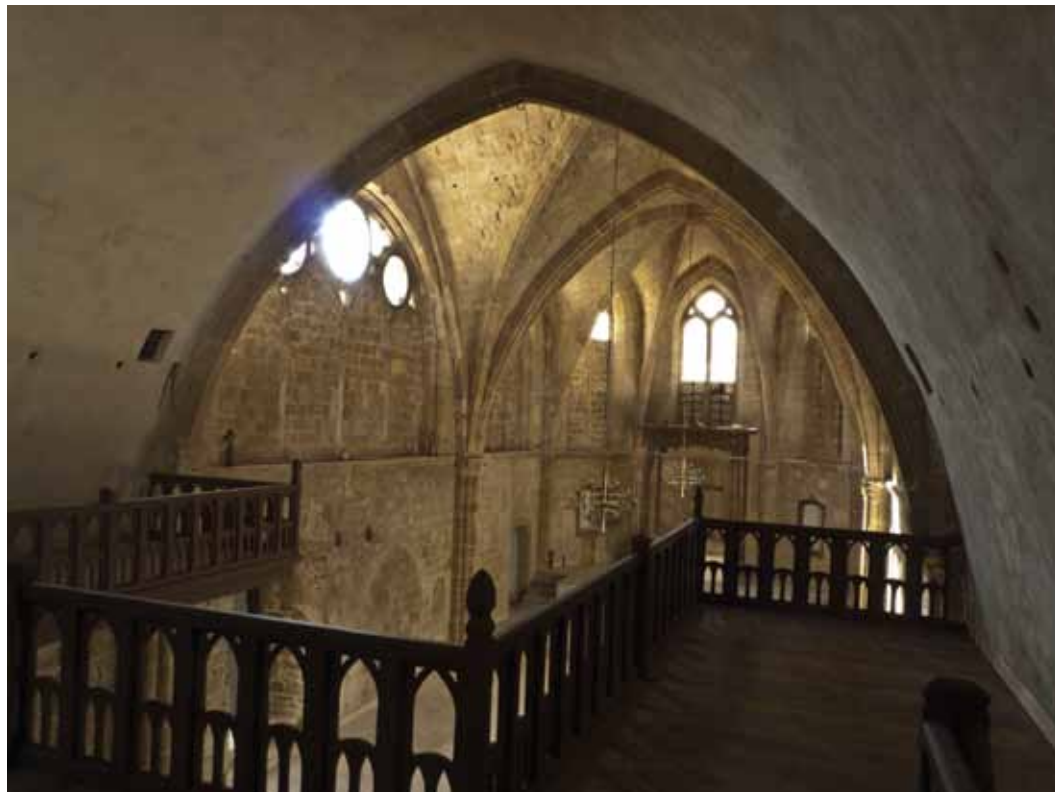
**Fig. 26** Church interior after the restoration. (UNDP-ACT)

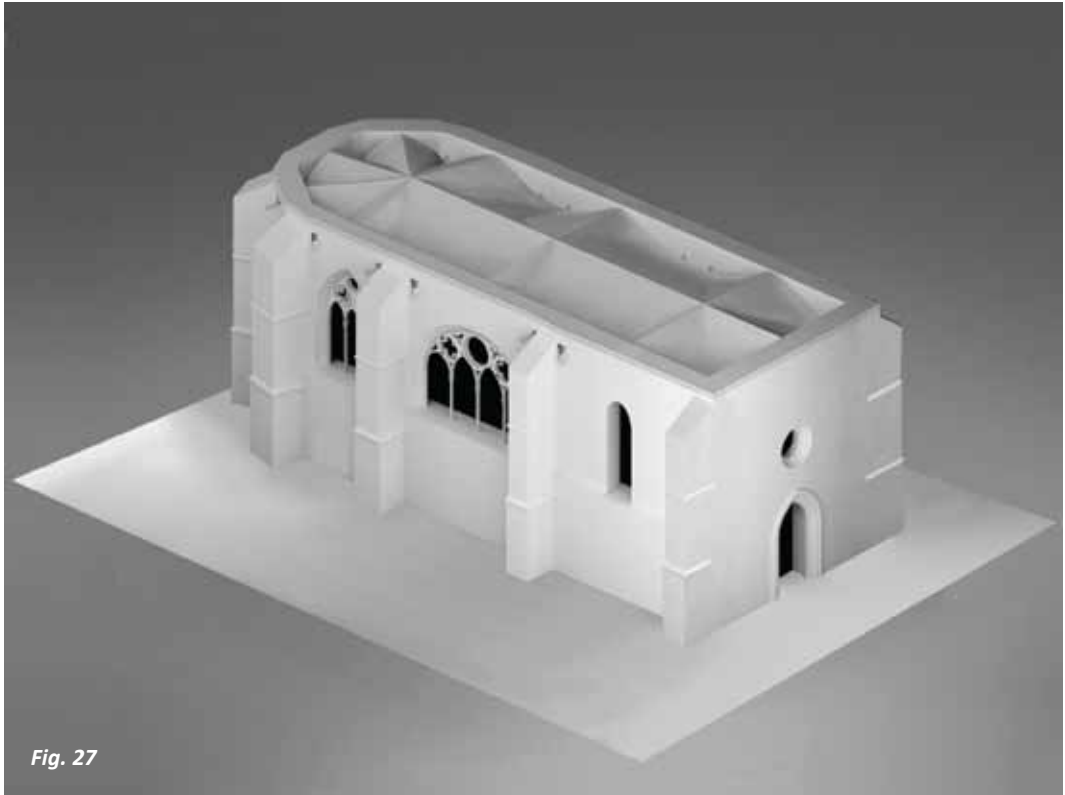
Fig. 27

**Fig. 27, 28, 29:** These are 3D models of the church showing the major structural changes. (Vitti-Zappis) *Page 26, 27, 28*

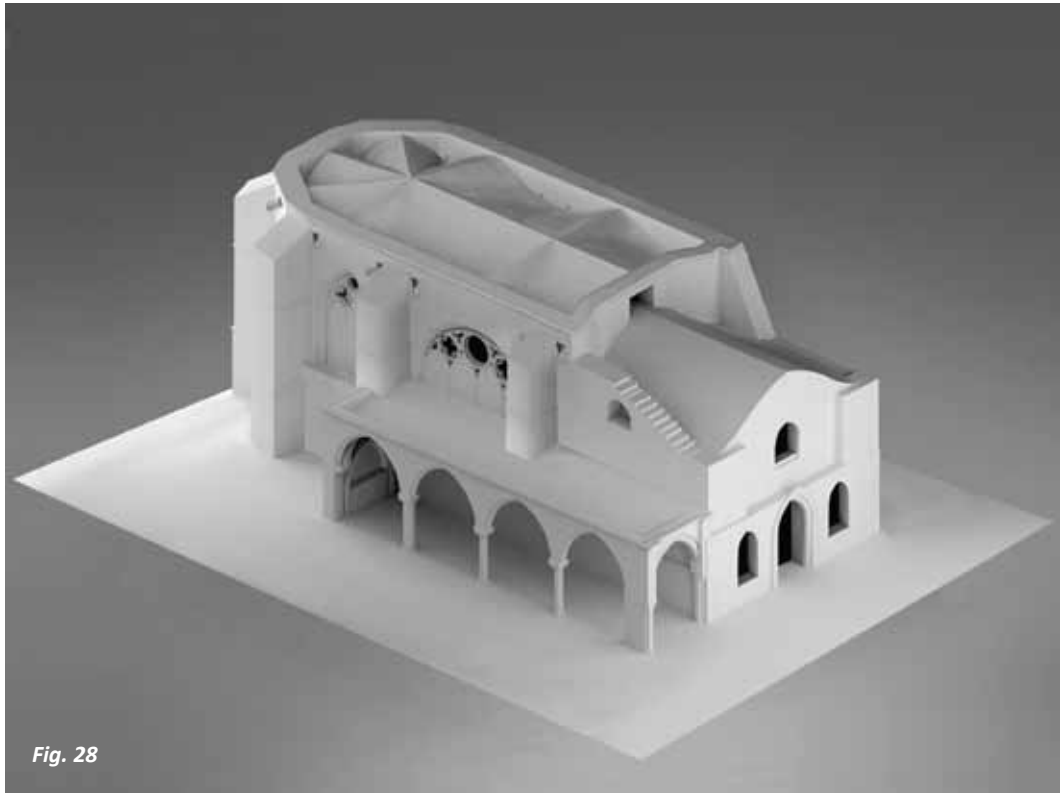
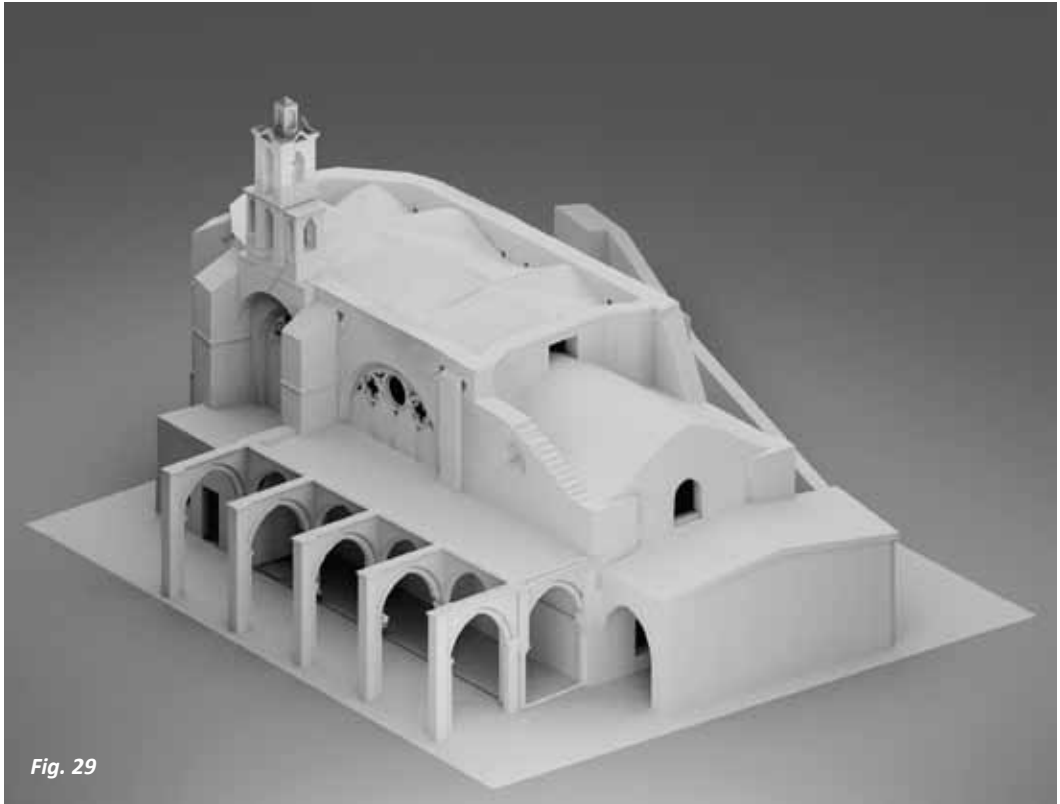
- **1312-1482:** Various burials (recorded by T. J. Chamberlayne, 1894) including
  - 1340- burial of Abbess Eschive de Dampierre in the Church
  - 1348- burial of thirteen nuns who died of the Black Death
- **1491:** Destructive earthquake causes the collapse of the church's first bay vault; the first bay is walled off from the rest of the church; a new doorway is opened on the south side
- **Early Sixteenth century:** Reconstruction of first bay vault and western facade; opening of the new north entrance; construction of the porch; walling up of niches and door passage in the apse; filling of the lower part of most of the windows

- **Beginning of the sixteenth century:** According to “Anagnosmata” ([1504] cited in Chebeyan 1955), the church was at this time in the hands of Armenians
- **15 May 1571:** Firman issued giving the church to the Armenians, after it had been used to store state salt
- **1688:** Restoration of the church
- **1783-1799:** Metropolitan Akob moves the premises of the Metropolis from the east side of the church to the present location in the west courtyard
- **1788:** Construction of a baptistery
- **Eighteenth to Nineteenth centuries:** Changes to the choir (new raised area, tiled surface facing the two bays and a wooden ciborium added to the altar, merging with the carved timber work from an older ciborium)
- **1858:** Construction of buttresses to support the porch
- **1860:** Construction of belfry, made possible by a donation of Hapetic Nevrouzian from Constantinople

- **1884:** Restoration of the church
- **1886:** Construction of Vartanaz school in front of the porch (replaced by building C in 1950)
- **1904:** Restoration of the church; the wall surfaces were plastered, ancient wood doors sawn off, the windows filled with new wood sashes with white and blue glasses
- **1921:** Construction of Melikian school (building D)
- **1938:** Construction of Ouzonian school (building E)
- **1945:** Women's gallery donated by the Dicran Ouzounian family
- **1950:** Restoration of the belfry (iron tie rods)
- **1950:** Construction of the nursery school (building C)
- **1960:** Renewal of church floor; some grave stones were removed from the floor at this time
