Infrastructure Damage Assessment

Cabo Delgado – Mozambique

August 2022

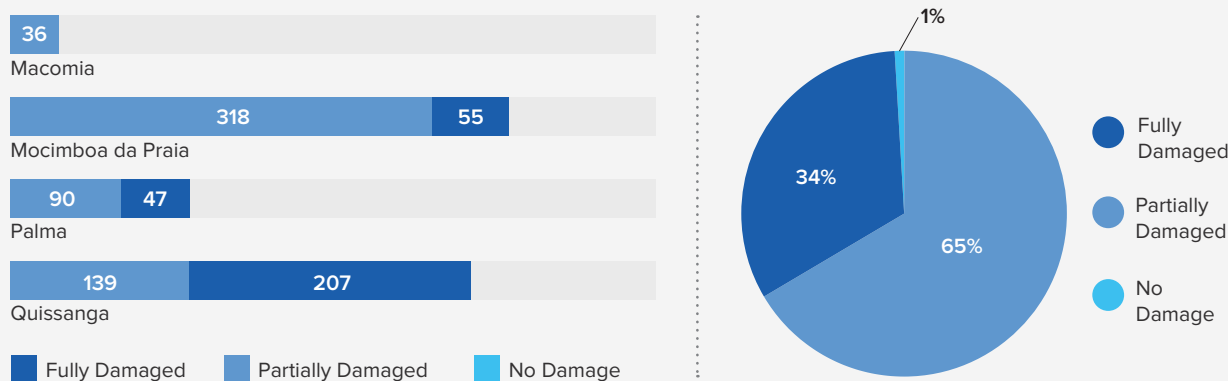
Figure 1: Damage to residential buildings (total=898)

Practically all the residential buildings surveyed were found to have been impacted by the conflict. While the largest share of the buildings had sustained partial damages, the share of residential buildings considered as fully damaged is relatively high. Out of the 898 buildings assessed, 65% or an equivalent of 583 buildings have been partially damaged while 34%, or 310 buildings, have been fully damaged (Figure 1). A district-wise comparison shows most of the buildings that are fully damaged are in Quissanga. More than half of the buildings assessed in this district are fully damaged, with a total of buildings fully damaged being 207, as compared to 139 that are partially damaged. In Macomia, almost all buildings assessed have sustained partial damage, while only one was fully damaged. The share of buildings that are fully damaged in Mocimboa da Praia is also relatively small; namely, 15% compared to 85% that are partially damaged.

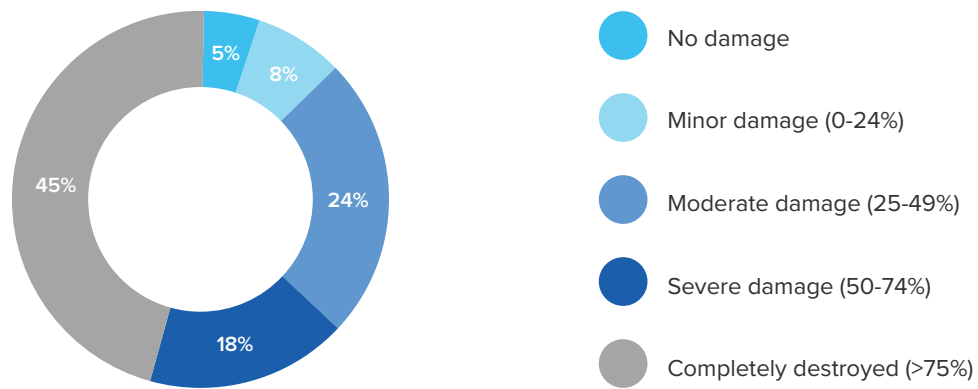
Figure 2: Damage to the electricity system (residential, N=568)

Another aspect of the buildings that is also of interest toward the recovery program concerns damage to electricity systems. Figure 2 illustrates that 45% of the 568 buildings connected to electricity have sustained full damage to their electricity system, which is relatively high as compared to the share of buildings for which the electricity system is either moderately damaged (24%) or severely damaged (18%). However, it should be noted that only 5% of the buildings still have an operational electricity system, while 8% have minor damage to their electricity system.

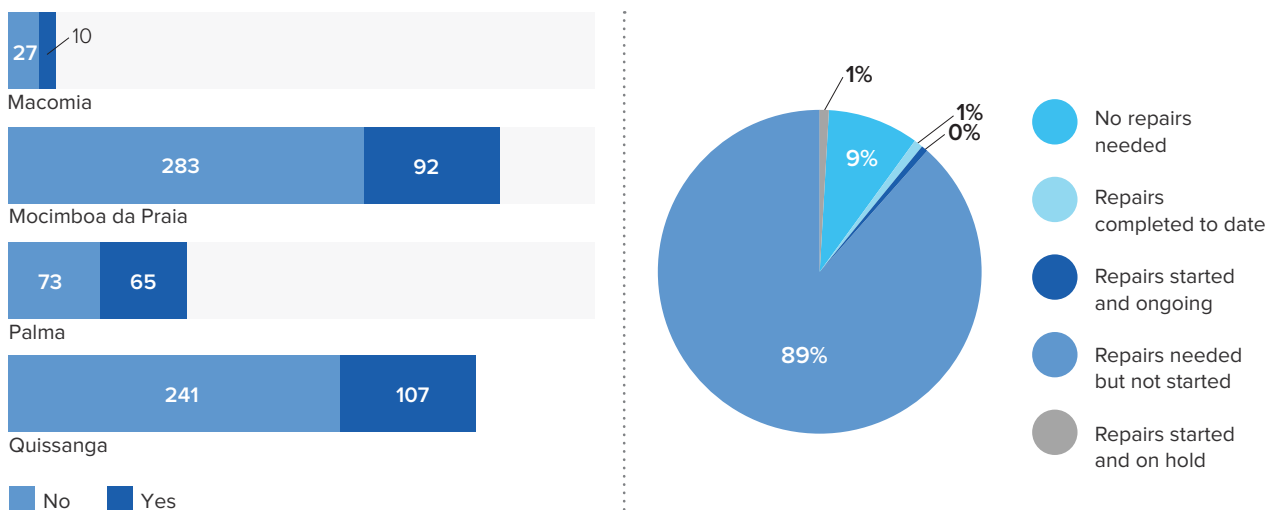
Figure 3: Number of buildings requiring urgent repairs and repairs done since the damage (residential/dwelling)

Under certain circumstances, some buildings require repairs more urgently than others. In this assessment, 274 residential buildings out of the 898 assessed need urgent repairs. Figure 3 (left) demonstrates that there is a positive correlation between the share of buildings that are fully damaged and the need for urgent repairs. As such, the district of Quissanga has the highest number of buildings that need urgent repairs among the districts covered by this assessment. One out of three buildings in this district require urgent repairs, with the total number of buildings needing urgent repairs amounting to 107. Beyond urgent repairs, Figure 3 (right) shows the share of buildings that require repairs, although these are not classified as urgent, as well as the repairs done since the damage. The figure demonstrates that the majority of the buildings assessed (89%) require repairs, which have yet to commence. Only a small share (1%) of the residential buildings assessed have the repairs completed.

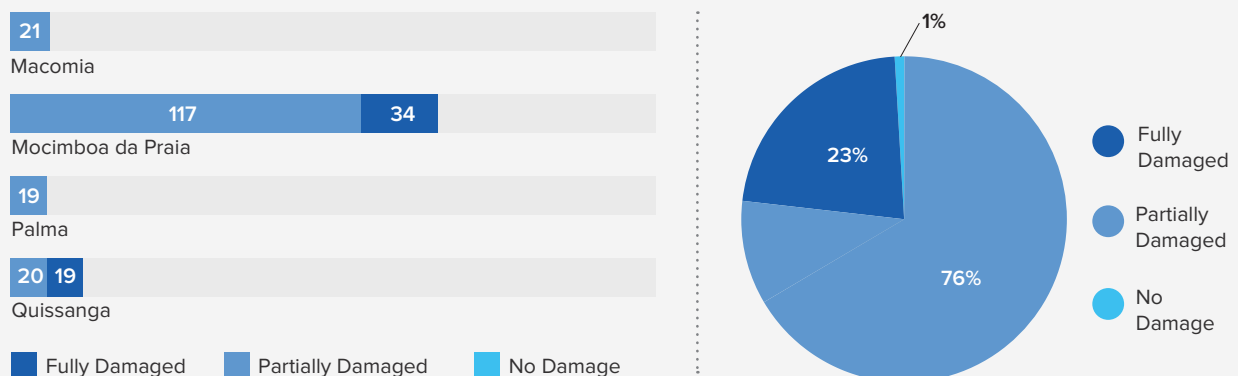
Figure 4: Damage to market/commercial facilities (total=232)

Markets or shopping centers hold significant value for the development of economic activities and income generation. Their destruction is expected to have an immediate impact on households' incomes, and the supply of food and other necessary goods. In this assessment, 232 market and commercial facilities were evaluated. Of these, 76% (177 facilities) were found to be partially damaged while 23% (55 facilities) are fully damaged (Figure 4). All the commercial facilities assessed in Macomia and Palma are partially damaged. Although the number of market and commercial facilities that are fully damaged in Mocimboa (34 facilities) is relatively higher than that in Quissanga (19 facilities), it remains that Quissanga has the proportionally largest share of markets fully damaged (48%, compared to 22% in Mocimboa). In fact, three out four of the market or commercial facilities evaluated in Mocimboa are partially damaged.

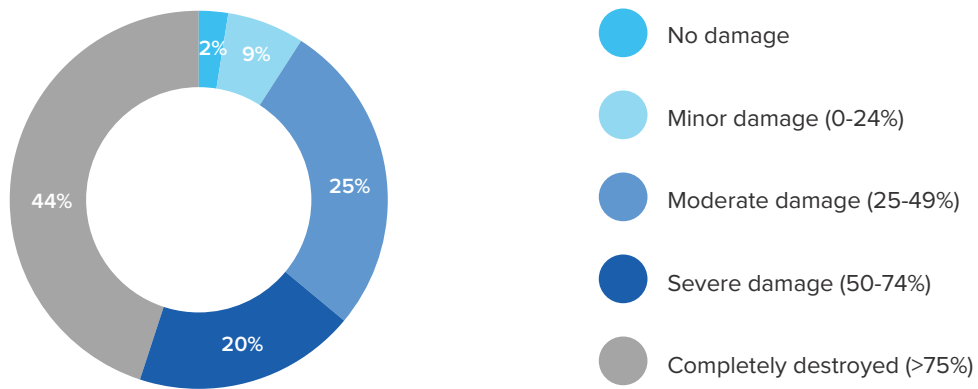
Figure 5: Damage to the electricity system (market/commercial facilities, N=192)

Akin to residential buildings, a significant share (44%) of the market and commercial facilities connected to electricity before the conflict have seen their electricity system destroyed (Figure 5). The share of commercial facilities for which the electricity system was severely damaged also remains relatively high (20%), which implies that more than half of the commercial facilities connected have encountered either severe damage or complete destruction. This is critical considering that some economic activities require electricity to operate. Furthermore, damage to the electricity system could result in unsafe environments and working conditions for those who would like to continue their economic activities, even if facilities are partially damaged.

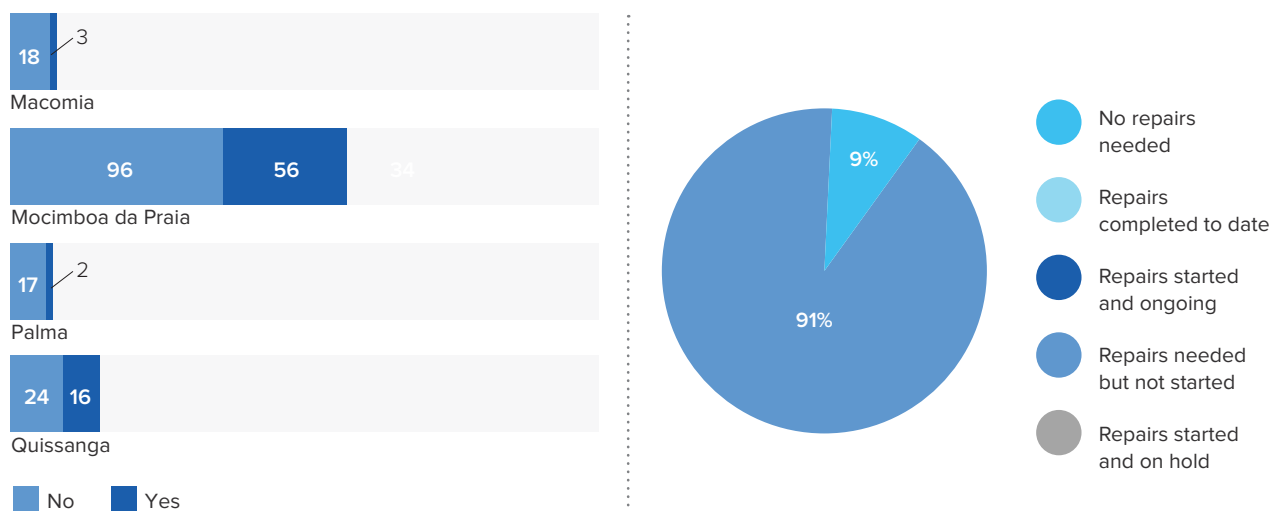
Figure 6: Number of market/commercial facilities requiring urgent repairs and repairs done since the damage

Of the 232 market or commercial facilities assessed, one out of three (77 facilities in total) require urgent repairs. We observe a positive correlation between the number of buildings that are fully damaged and the need for urgent repairs (right-side of Figure 4 and the left-side of Figure 6). The left-side of Figure 6 also indicates that most of the market facilities that require urgent repairs are in Mocimboa da Praia (56 facilities).

Although most of the markets assessed are not in urgent need of repair, many are still in need of repair in the short or medium term due to the damage they have sustained. As shown on the right-side of Figure 6, a striking 91% of the market facilities are in need of repairs, but the repairs have not started yet.

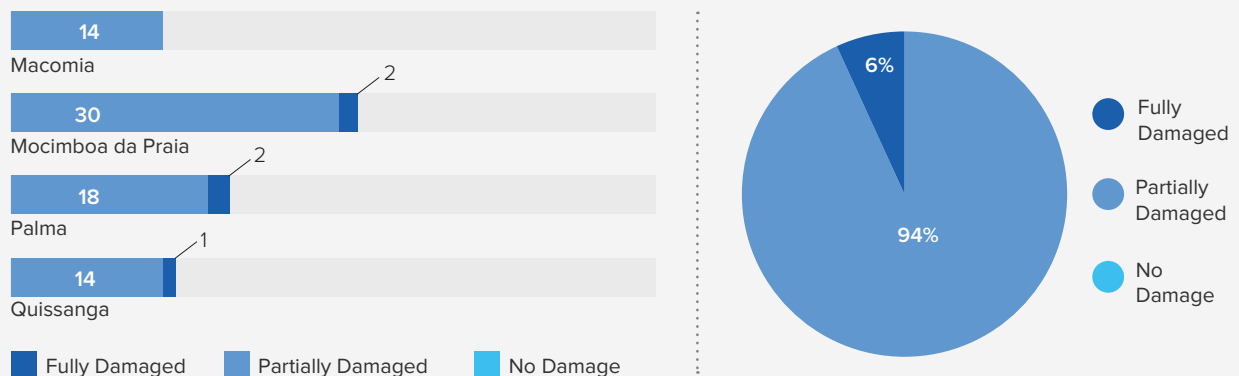
Figure 7: Damage to office facilities (total=81)

All office facilities assessed have suffered damage either partially or fully. The majority (94%), however, has sustained partial damage while only 6% are fully damaged (Figure 7). This trend is also observed at district level. The districts in which office facilities were fully damaged are Mocimboa da Praia (two facilities), Palma (two facilities), and Quissanga (one facility). The remaining office facilities in these districts are only partially damaged.

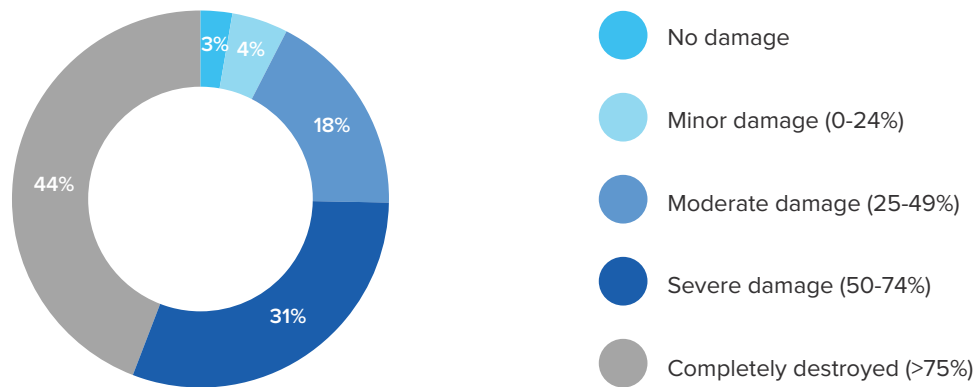
Figure 8: Damage to the electricity system (office, N=68)

While most office facilities have faced partial damage to the overall building, those connected to the electricity system have encountered severe damage. This is illustrated by Figure 8 which depicts that only 3% respectively 4% of the facilities assessed have no or minor damage to the electricity system. Two out of three (65%) office facilities have sustained either a severe level of damage or the complete destruction of their electricity system. A total of 31% have seen their electricity systems severely damaged, while most (44%) have had their electricity systems destroyed.

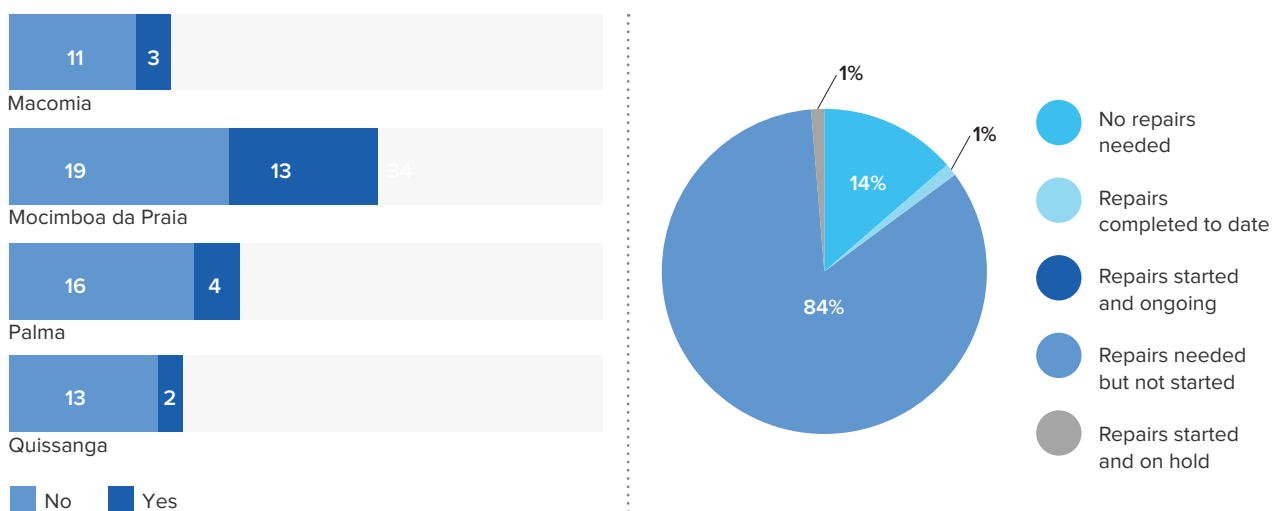
Figure 9: Number of office facilities requiring urgent repairs and repairs done since the damage

While most office facilities assessed are partially damaged, one in four office facilities (22 facilities) require urgent repairs. Over half (13 facilities) of these are in Mocimboa da Praia (left side of Figure 9). Regarding the office facilities requiring urgent repairs in the other districts assessed, three (03) are in Macomia, four (04) are in Palma, and two (02) in Quissanga.

While some facilities do not need urgent attention, repairs are still required in the medium or long run given the damages they have encountered. This is shown in Figure 9 (right), with 86% office facilities requiring repairs. Only one office facility has had repairs completed to date while one has repairs started but on hold.

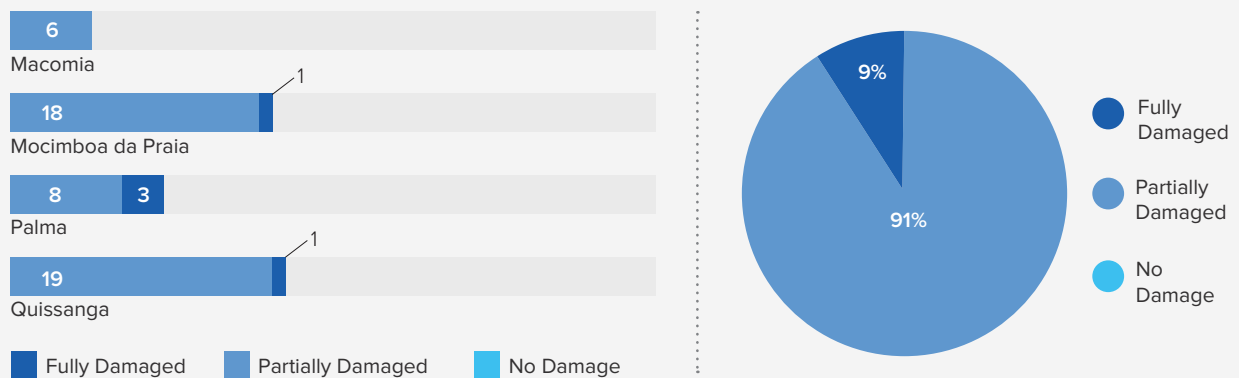
Figure 10: Damage to educational facilities (total=56)

Education is one of the development-related priorities of the United Nations, as stipulated within the Sustainable Development Goal (SDG) 4. One aspect of this is to ensure that all children have access to free, equitable and quality primary and secondary education. This can only be achieved through the availability of quality and functional education facilities. Hence, by extension, this assessment examines the impact of the conflict on educational facilities and finds that all the 56 education facilities have been damaged by the conflict. A large share of them (91%) have sustained partial damages while a small part (9%) has been fully damaged. This pattern is confirmed at the district level, with only 5 education facilities having been fully damaged across three districts, Mocimboa da Praia (3 facilities), Palma (1 facility) and Quissanga (1 facility).

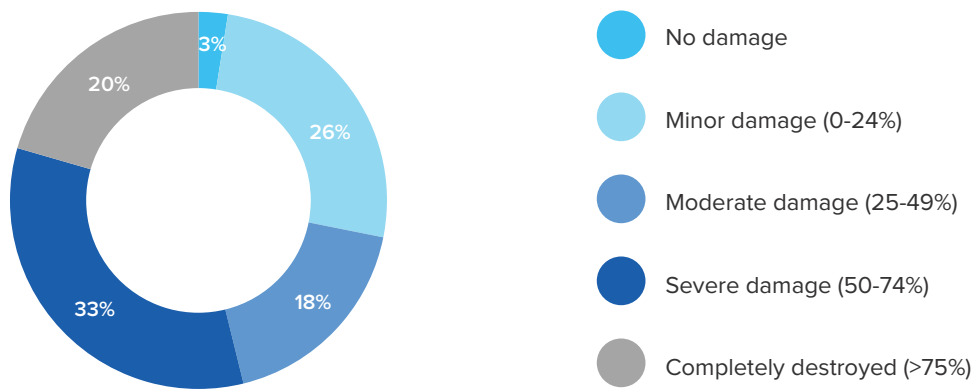
Figure 11: Damage to the electricity system (education facilities, N=39)

The electricity system has also been damaged in almost all of the educational facilities connected to electricity before the attacks. The largest share of them (33%) sustained severe damage to their electricity system, while 20% had their electricity system destroyed. However, it is notable that one out four educational facilities have sustained only minor damage to their electricity system.

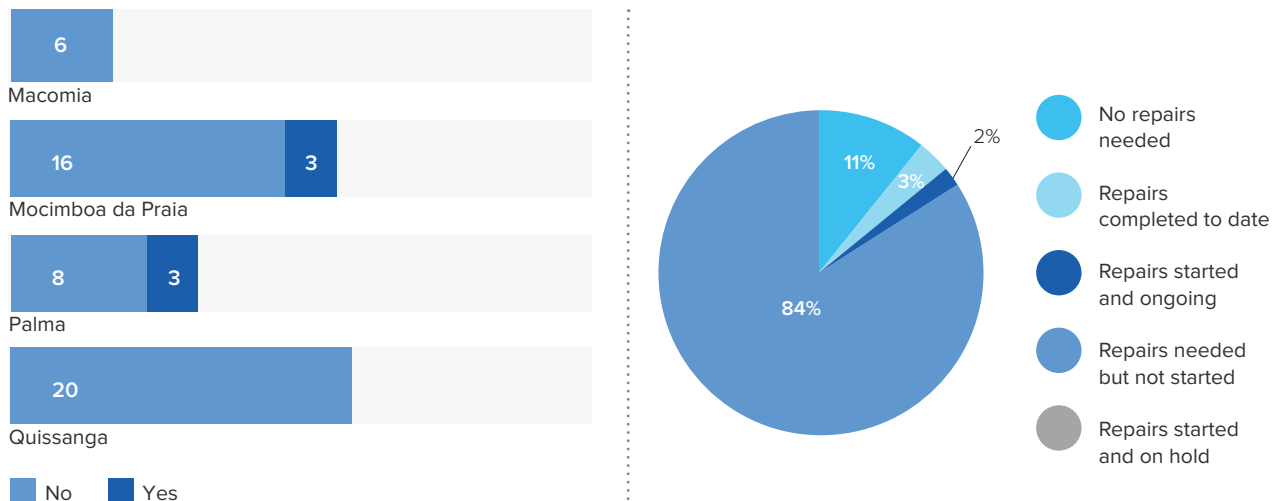
Figure 12: Number of educational facilities requiring urgent repairs and repairs done since the damage

The share of educational facilities requiring urgent repairs is low (10%), compared to other types of buildings. Only 6 out of 56 surveyed need urgent repairs, with half being in Mocimboa da Praia and the second half in Palma (left side of Figure 12). All educational facilities assessed in Macomia and Quissanga do not need urgent repairs. However, this does not mean that they do not require repairs at all. As shown in the right side of figure 12, 84% require some type of repairs. While only 3% have repairs completed to date, 2% have repairs that have started and are ongoing.

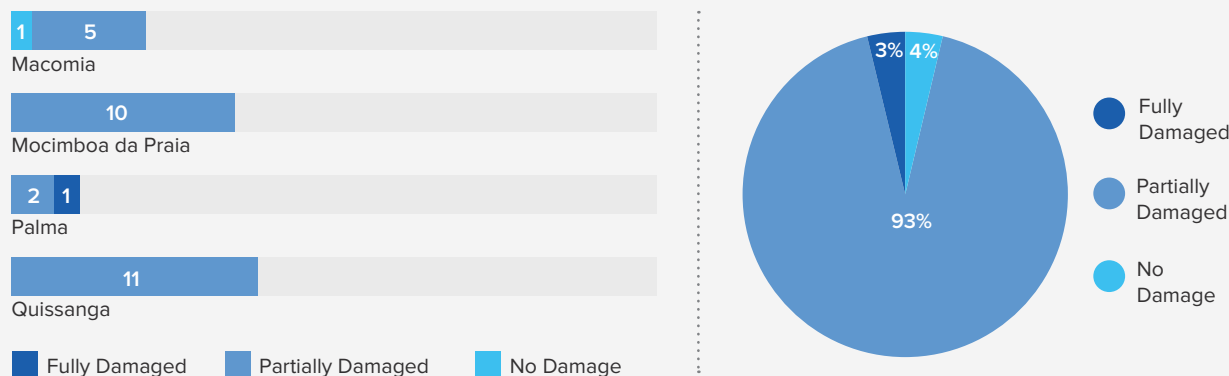
Figure 13. Damage to health facilities (total=30)

Health capital is essential to sustainable development especially in all low-income areas, including Cabo-Delgado. Of the 30 health facilities examined for the purposes of this assessment, the majority (93%) have been partially damaged while a minor 3% has been fully damaged (Figure 13). Only 4% sustained no damage as a result of the conflict. Putting these figures in numbers distributed by districts, it is found that only one health facility, located in Macomia, is not damaged. Furthermore, there is only one health facility that was fully damaged, which is in Palma. All health facilities assessed in the two remaining districts, Mocimboa da Praia and Quissanga, are partially damaged.

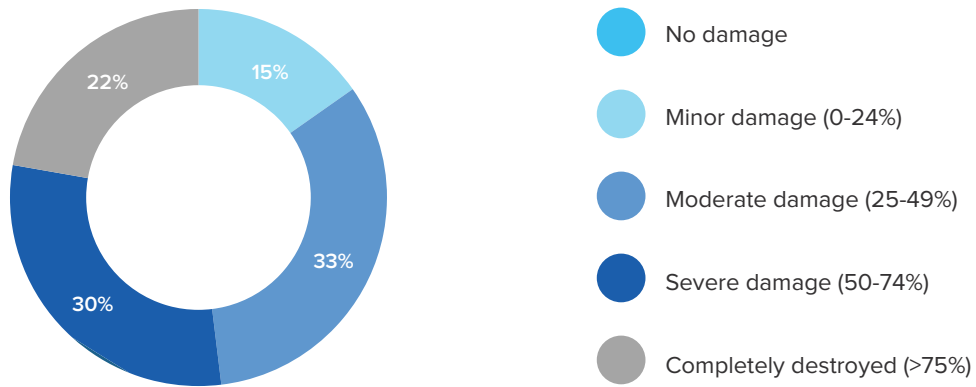
Figure 14: Damage to the electricity system (health facilities, N=27)

All the health facilities connected to electricity have faced damage to their electricity system. Most of them (33%) have endured a moderate level of damage to their electricity system (Figure 14). However, a sizeable share (30%) has sustained a severe level of damage to electricity systems, while a notable share (22% of the buildings with electricity) has seen its electricity system completely destroyed.

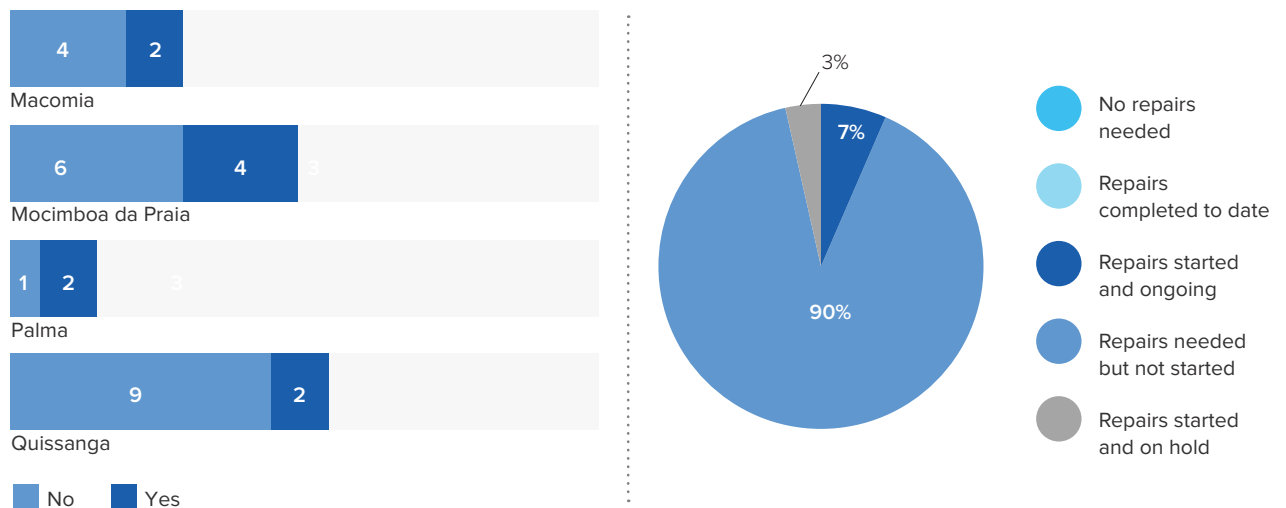
Figure 15: Number of health facilities requiring urgent repairs and repairs done since the damage

One out of three (10 facilities) of the 30 health facilities assessed require urgent repairs. The left-hand side of Figure 15 shows that, in all the four districts assessed, there are two to four health facilities that need urgent repairs due the damages sustained. Four are in Mocimboa da Praia. The other districts assessed each have two facilities requiring urgent repairs.

Although the number of health facilities that need urgent repairs is limited, there is still a large number that require repairs in the short and medium term. As shown in the right-hand side of Figure 15, all health facilities assessed require repairs. The majority (9 out of 10) need repairs, but none have commenced. Only two health facilities (7%) have repairs started and ongoing, while one health facility has repairs started and on hold.

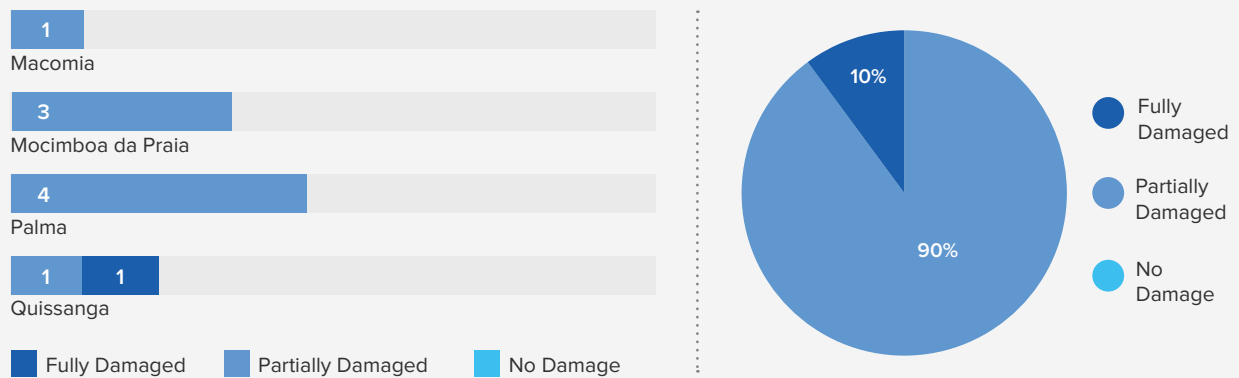
Figure 16: Damage to police stations (total=10)

9 out of 10 police stations surveyed have been partially damaged, while the remaining one is fully damaged. Across all districts, only one police station has been fully damaged, and it is located in Quissanga (see Figure 16).

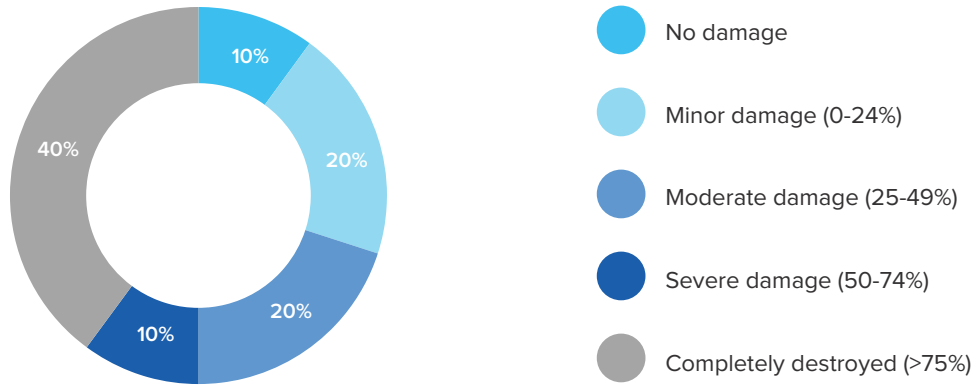
Figure 17: Damage to the electricity system (police stations, N=10)

Regarding the electricity system, most police stations have been confronted with the destruction of their electricity systems. This is illustrated in Figure 17, with 4 out of 10 having their electricity systems destroyed. On the other hand, one police station is severely damaged, two are moderately damaged and two others only have minor damages.

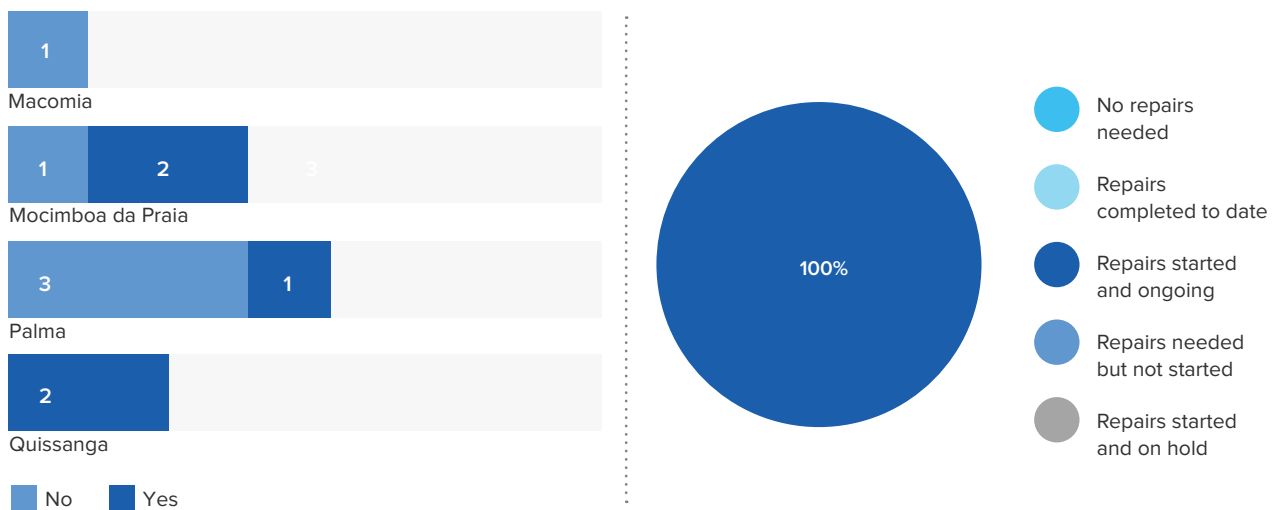
Figure 18: Number of police stations requiring urgent repairs and repairs completed since the damage

Half of the police stations assessed require urgent repairs, with two in Mocimboa da Praia, one in Palma, and the remaining two in Quissanga (left side of Figure 18). It is noted that both police stations assessed in Quissanga require urgent repairs.

Beyond the urgent repairs, all the police stations assessed need repairs in the short or medium term, but these have not yet commenced.

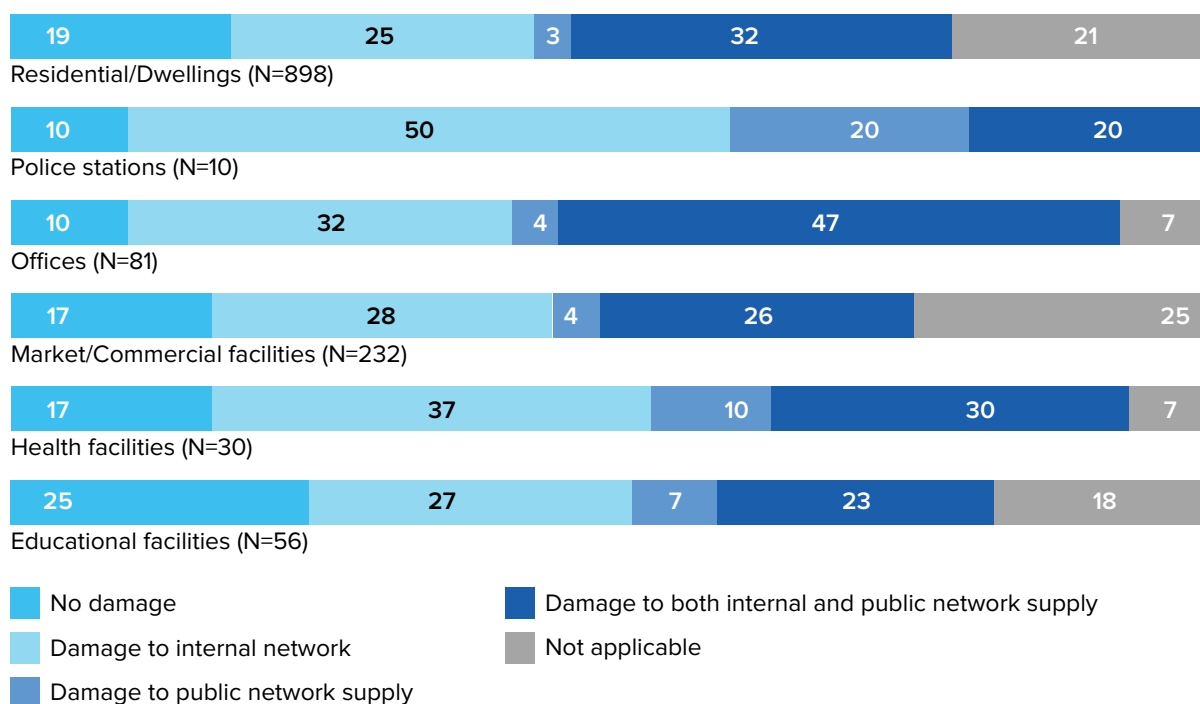
Figure 19: Damage to the water supply system (in %)

The NSAGs attacks have worsened matters. Over half the buildings surveyed currently do not have access to drinking water. The existing water infrastructures have also been damaged in most of the buildings assessed. Residential buildings, as well as the offices facilities have mostly faced damages to both the internal and external water supply networks, 32% and 47% of the buildings, respectively (Figure 19). Half of the police stations have encountered damage to their internal water network. Most educational and commercial facilities have also sustained damage to their internal water networks, at 27% and 28%, respectively. However, there is no significant difference between the proportion that only faced damage to the internal network and that experiencing both internal and external damages. Like market and educational facilities, health facilities have mostly registered damages to their internal water network, with one out of three facing such impact.

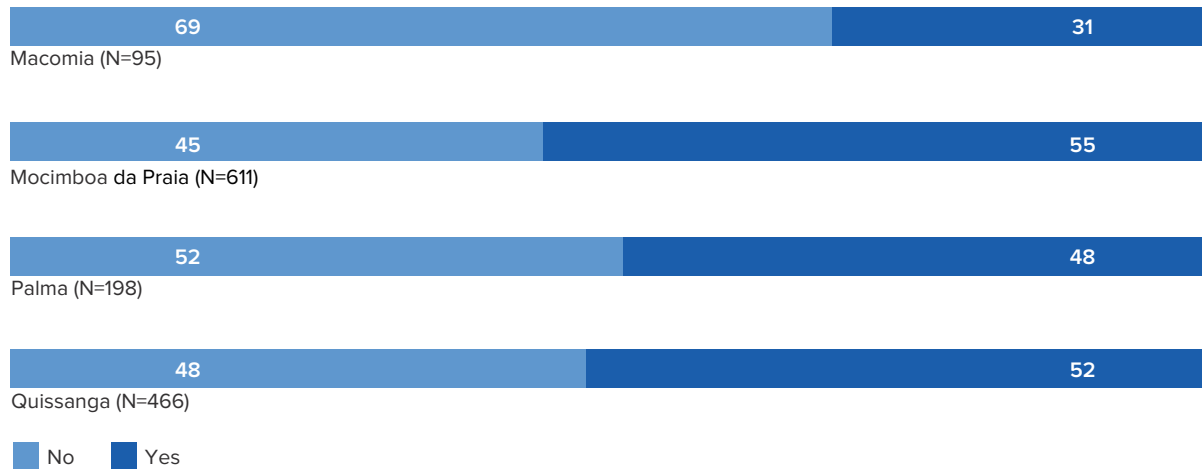
Figure 21: Share of buildings that will require debris management by districts (in %)

One of the key topics covered by this assessment is related to debris management. In this section of the report, we delve into issues related to buildings that require debris management; the type of debris that is present; debris with the presence of asbestos; debris that can be reused/recycled; and, potential hazards related to debris removal. About 50% of the assessed buildings in Mocimboa da Praia (55%), Quissanga (52%) and Palma (48%) require debris management strategies (see Figure 21). Only 1 in 3 assessed buildings in Macomia (31%) require such services, meaning that the vast majority of buildings within this district do not require debris management operations (69%).

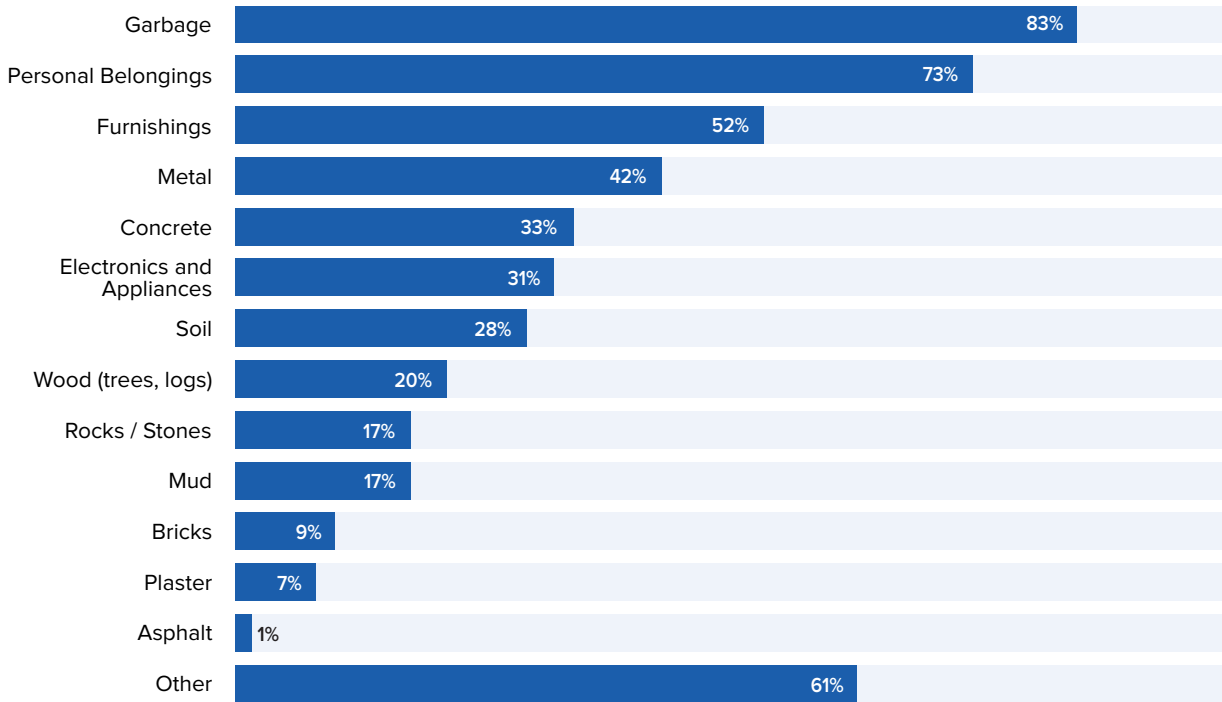
Figure 22: Type of debris that is present (in %)

Garbage (83%), personal belongings (73%) and furnishings (52%) represent the three most prevalent types of debris, succeeded by metal (42%), concrete (33%), and electronics (31%). The least prevalent type of debris are asphalt (1%), plaster (7%) and brick (9%).

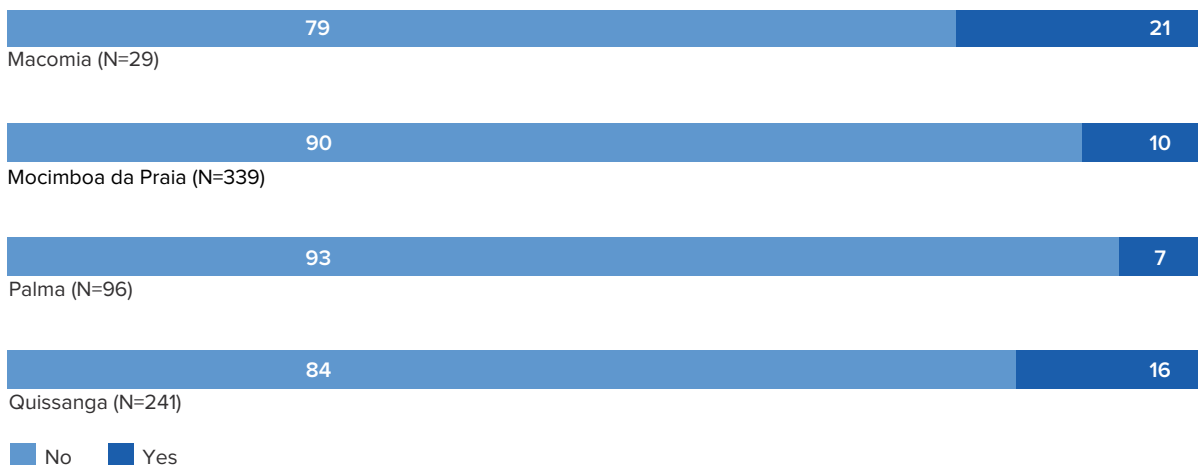
Figure 23: Share of debris composed of asbestos (in %)

In the assessed districts, the share of debris containing asbestos is relatively small. Some 21% of the debris in Macomia contain asbestos (Figure 23). This figure is reduced to 16% in Quissanga, 10% in Mocimboa, and 7% in Palma.

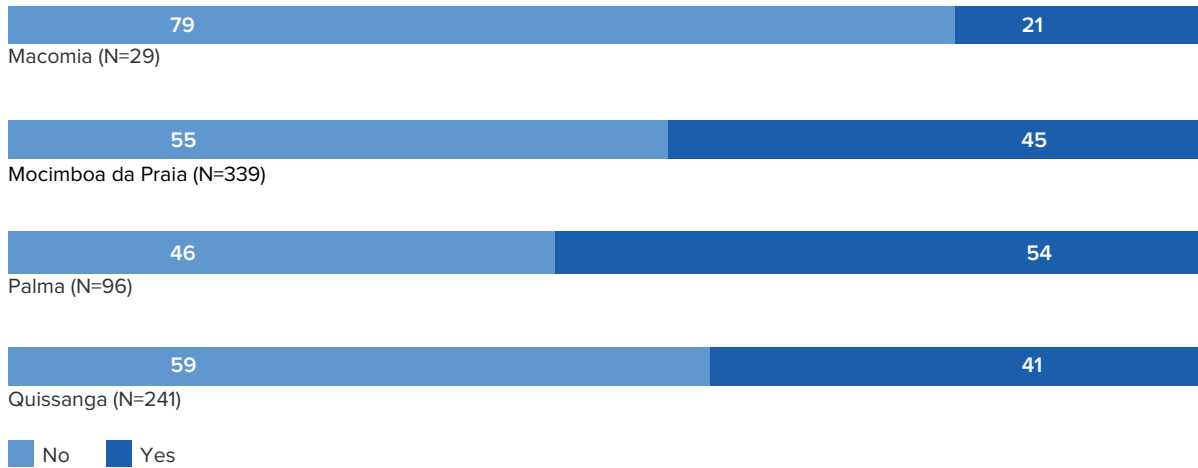
Figure 24: Share of debris that can be reused/recycled (in %)

Advantageously, a significant share of debris can be reused or recycled. In fact, this assessment reveals that 44% of the debris present in the buildings assessed can be reused or recycled. Palma has the highest share, with more than half (54%) of the debris being reusable (Figure 24). In Mocimboa da Praia and Quissanga, the share of reusable debris is 45% and 41%, respectively. Macomia has the lowest share of reusable or recyclable debris, with only 20% being reusable.

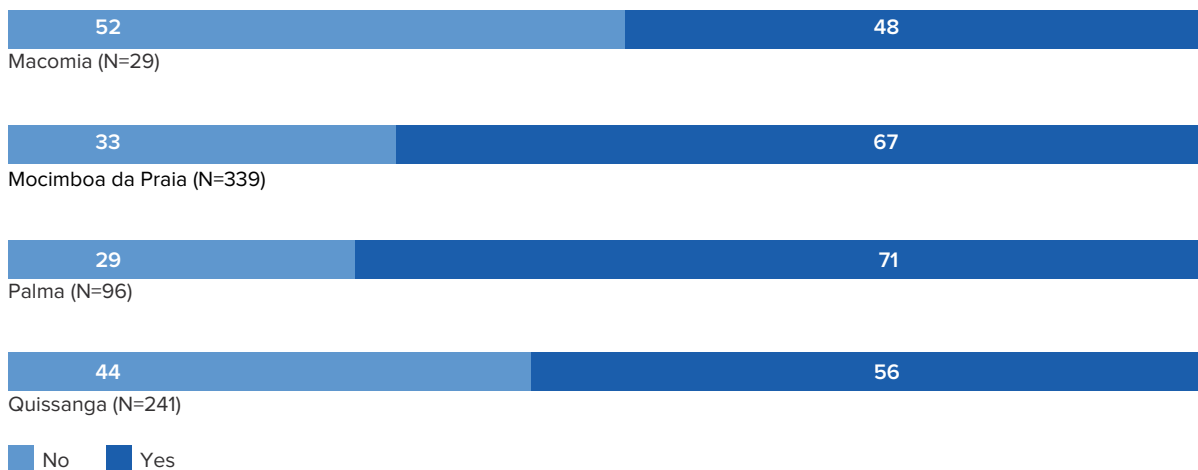
Figure 25: Will debris removal create any potential hazards? (in %)

Debris management can present potential risks or result in the presence of hazards or hazardous environments. In almost two out of three situations, debris removal is expected to create a potential hazard. Risks of this are markedly high in Palma where, in 71% of cases, debris removal can create a potential hazard (Figure 25). The number is also high in Mocimboa da Praia and Quissanga, with 67% and 56% debris removal being classified as high-risk activities. In Macomia, while the number is relatively lower, half the debris might create risks upon removal operations.

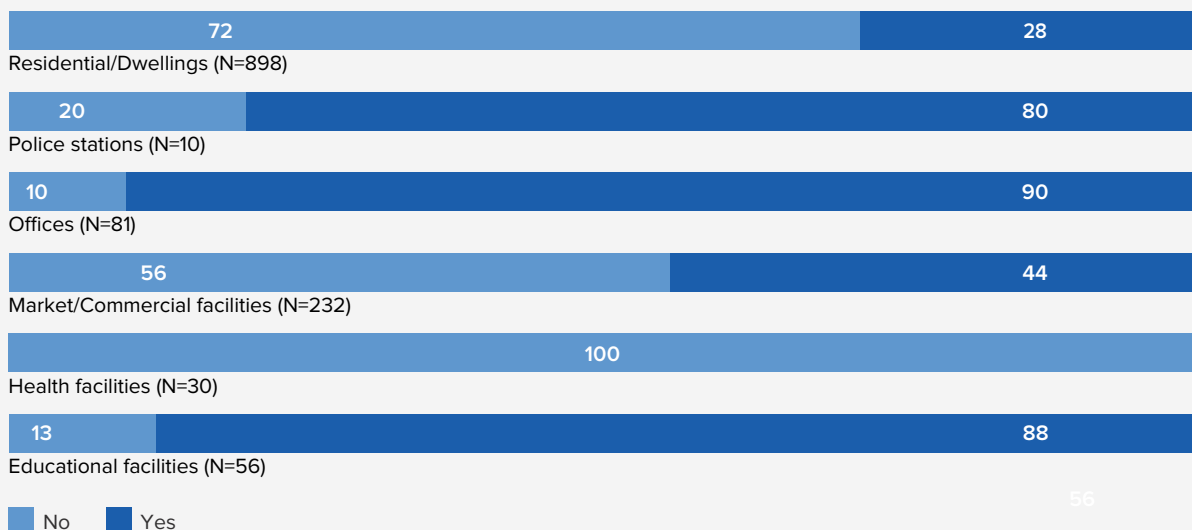
Figure 26: Built in compliance of the building codes (in %)

The majority of residential/dwelling buildings and market/commercial facilities are not compliant with the building codes (see Figure 26). The poorest rate of compliance with building codes are found among residential and dwelling buildings, where 72% are not compliant. The second poorest compliance is observed among markets and commercial facilities – 56% of these are not compliant. Buildings used by public service providers reflect the highest shares of buildings built following the building codes (health facilities, 100%; offices, 90%; educational facilities, 88%; and police stations, 80%). While interpreting these figures, it is important to note the number of observations per type of building category. This information is plotted within the graph below (Figure 26).

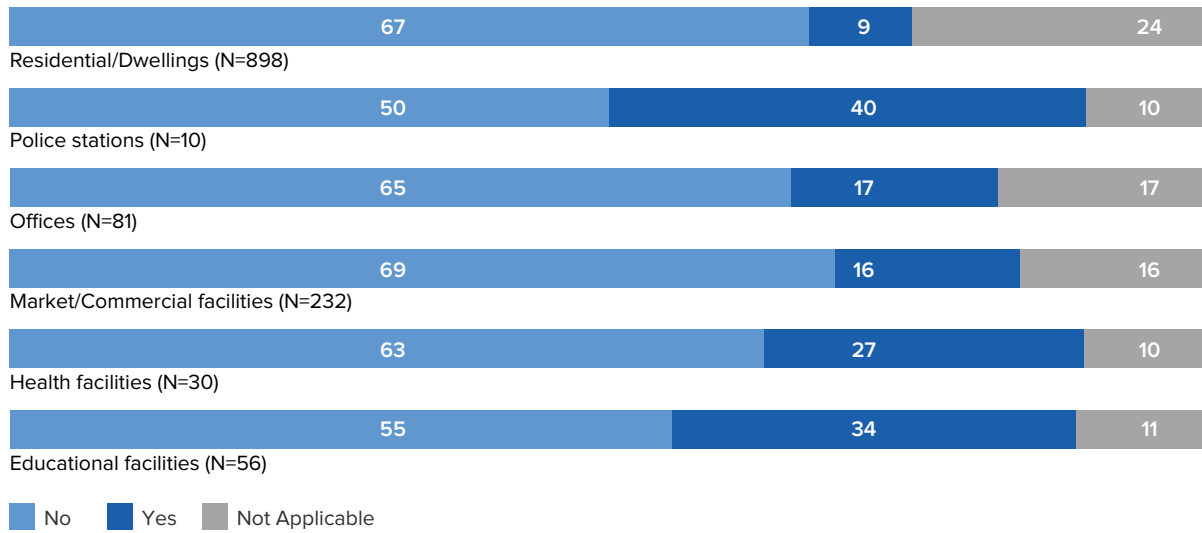
Figure 27: Building roof reinforced with cyclone straps or similar to prevent lift-off (in %)

Another component examined in this assessment concerns roofs and their reinforcement by means of cyclone straps or similar to prevent detachment. Figure 27 illustrates the share of buildings which have or do not have reinforced roofs for cyclone resilience. Owing to these figures, we surmise that there is room for improvement in this regard. The lowest shares are found within residential/dwelling buildings (9%), followed by market/commercial facilities (16%).

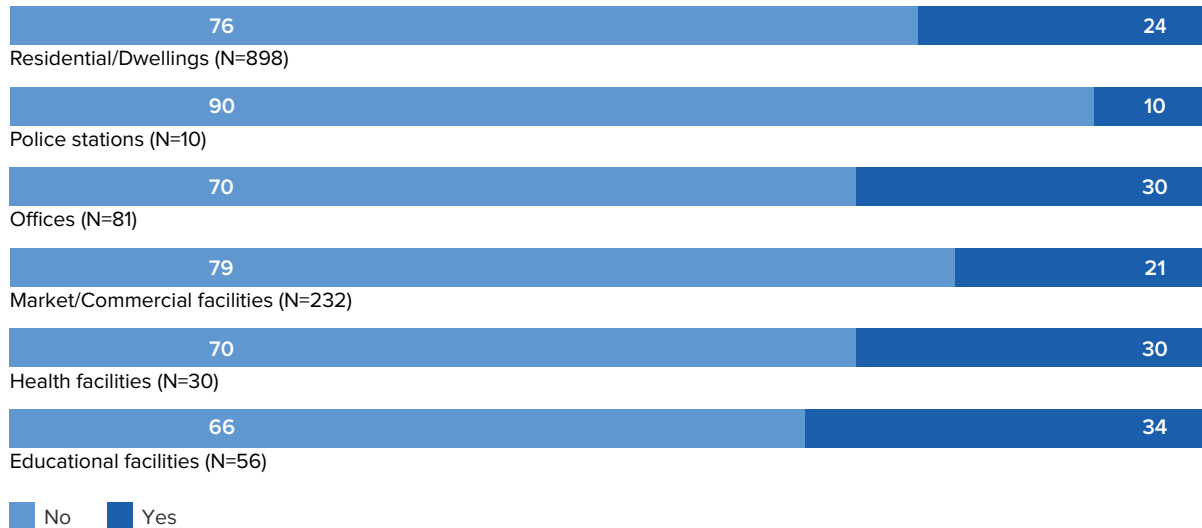
Figure 28: Presence of trees and/tall structures near the building that could become a threat to the building (in %)

The presence of the trees and tall structures near the buildings can generally be characterized as potential hazards. For this reason, the survey covered this aspect by including in the questionnaire a question that points out to this issue. Overall, one in four buildings are near trees or tall structures that could pose risks to infrastructure. The highest rates are recorded in educational facilities (34%), followed by health facilities (30%) and offices (30%).

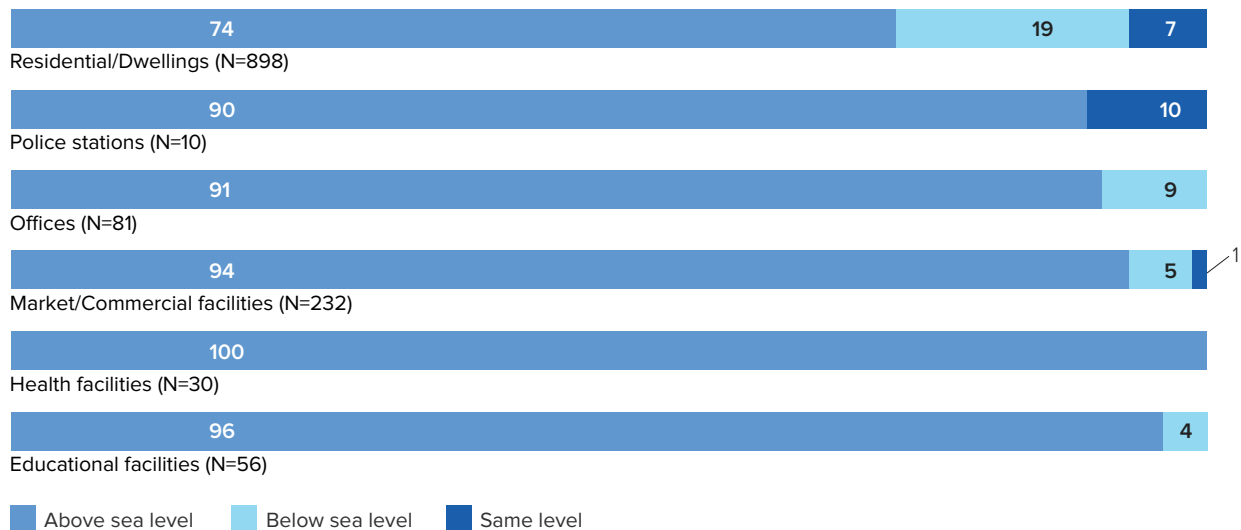
Figure 29: Building ground level in comparison to the sea level (in %)

Coastal infrastructure can be jeopardized by rises in sea levels. This assessment finds that one in four residential/dwelling buildings are exposed to such risks, as their ground levels are at sea level (7%) or below sea level (19%). Other categories of buildings are not highly exposed to such risks – only 10% or less of other buildings mapped have their ground levels at sea levels or below. Figure 29 offers additional details in this regard.

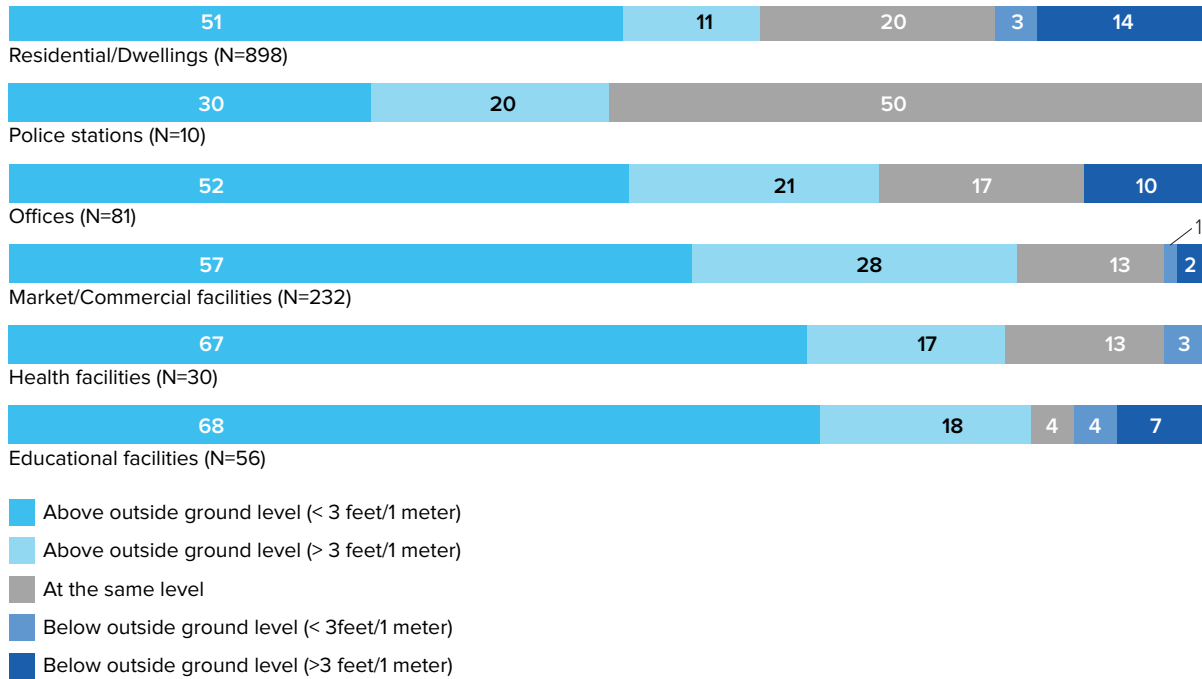
Figure 30: Building ground level in comparison to the outside ground level (in %)

In response to the results of this assessment regarding the ground level in comparison to the sea level, a question was added in the questionnaire to collect information about the ground level of the buildings in comparison to the outside ground level. Such information is plotted in Figure 30. In most cases, the building ground level is found to be above the outside ground level. It is most common for the building ground level to be at below 3 feet/1 meter above the outside ground level. A slightly smaller share has their ground level at above 3 feet/1 meter – this is relatively common for instance among the markets/commercial facilities (28%), offices (21%) and police stations (20%). There is reason for concern, however, with regard to the dwellings and residences and the offices surveyed – among these, 17% respectively 10% have the ground level the outside ground level.
